**ARCHITECTURAL HERITAGE  
ASSESSMENT  
AT  
GOOD COUNSEL CENTRE  
TAYLOR'S LANE  
BALLYBODEN  
DUBLIN 16**

**ON BEHALF OF:  
SHANNON HOMES DUBLIN UNLIMITED COMPANY**

**AUTHOR: ROB GOODBODY**

**MARCH 2023**

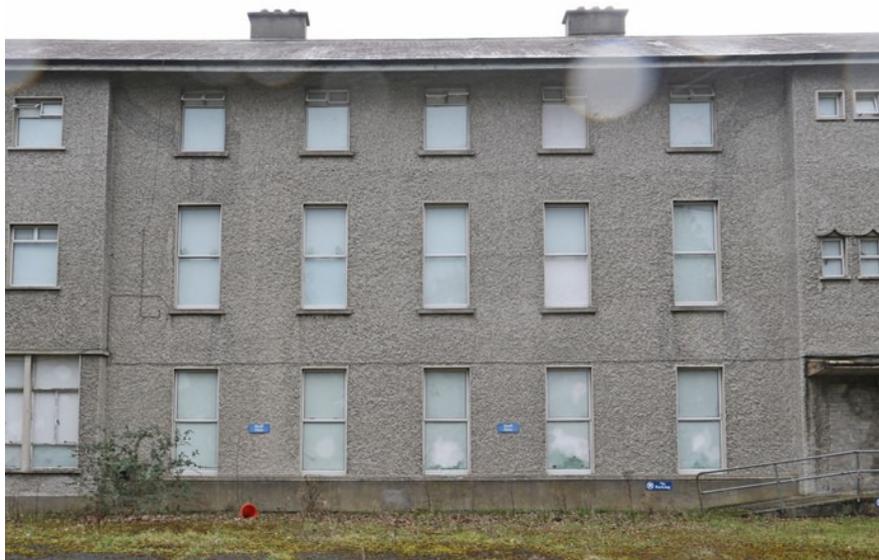
*Plate 3: Front façade of former house*

The remains of the late nineteenth century house, St Catherine's Park, are incorporated within the long east-west range of the building. The only indications on the front façade are the fenestration and the presence of chimneys. The windows are vertical, with smaller windows on the top floor, though the original sash windows have been replaced by aluminium casements. There is no door in the former front of the house and the façade has been rough cast rendered, in common with the rest of the institutional building; the roof also dates from the 1950s and is slated.

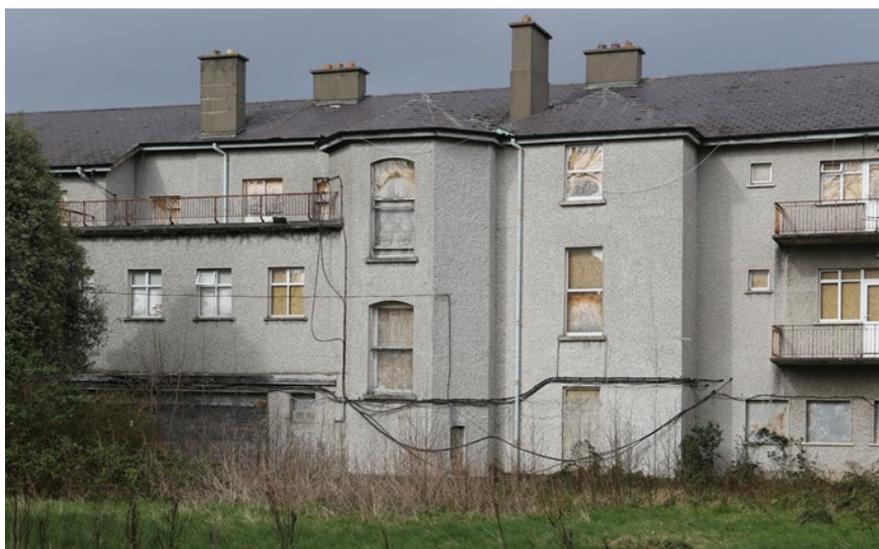
*Plate 4: Rear elevation of former house*

At the rear of the former house a full-height canted bay projects from the centre of the façade. To the west of the staircase the building has a two-storey element, to the rear of which the building rises to its full three storeys. The projecting bay has two one-over-one timber sliding sashes and a small timber sash survives on the top floor. The rest of the windows are later uPVC casements.

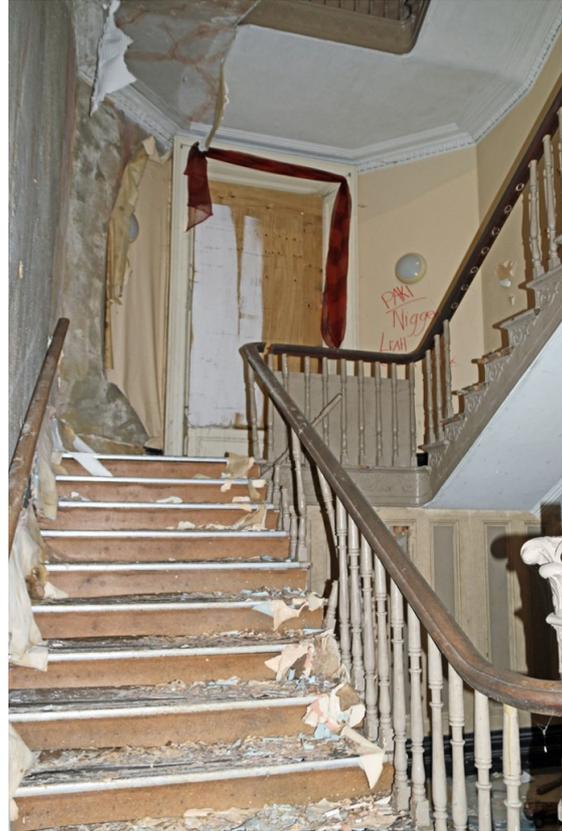
The stair is open string, with fretted tread ends. The balustrade has turned balusters that support a hardwood handrail, though significant numbers of the balusters have been broken. At the foot of the stair is a substantial newel, decoratively carved, though with the upper part missing. The area beneath the stair is enclosed by vertical timber panelling.

*Plate 7: Staircase at ground-floor level*

- Roof slates
- Four-panelled doors and their architraves
- Remaining window shutters
- Balusters and newel post from staircase
- Pews from the chapel
- Confessional
- Dedication stone

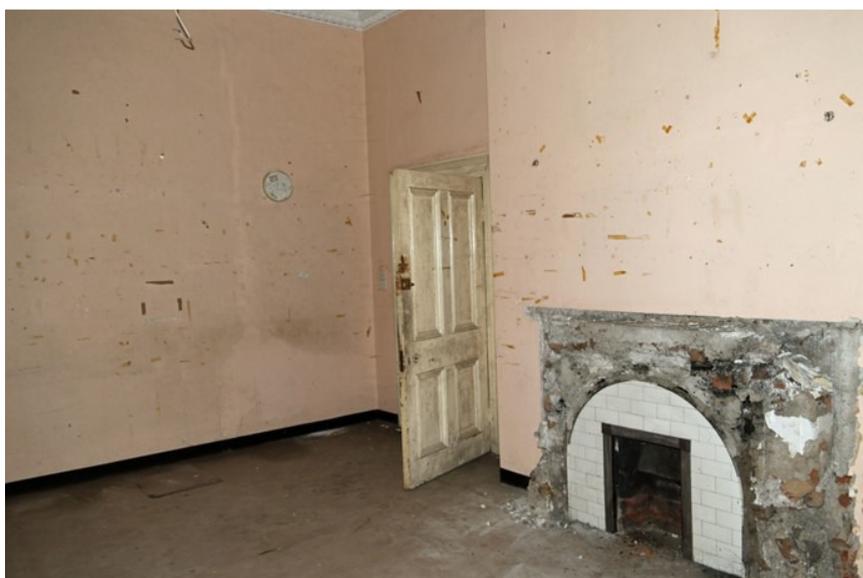
The arts and crafts room is to the east of the former entrance hall, at the front of the house. The room is entered via a four-panelled door set in a moulded-timber architrave. The room is lit by two windows, with moulded-timber architraves; the shutters are missing. The doorway from the former entrance hall is not seen on this side of the wall. The room has a decorative cornice, edged with egg and dart moulding. There is a chimneybreast, while the chimneypiece is missing.

*Plate 10: Hearth and doorway in arts and crafts room*

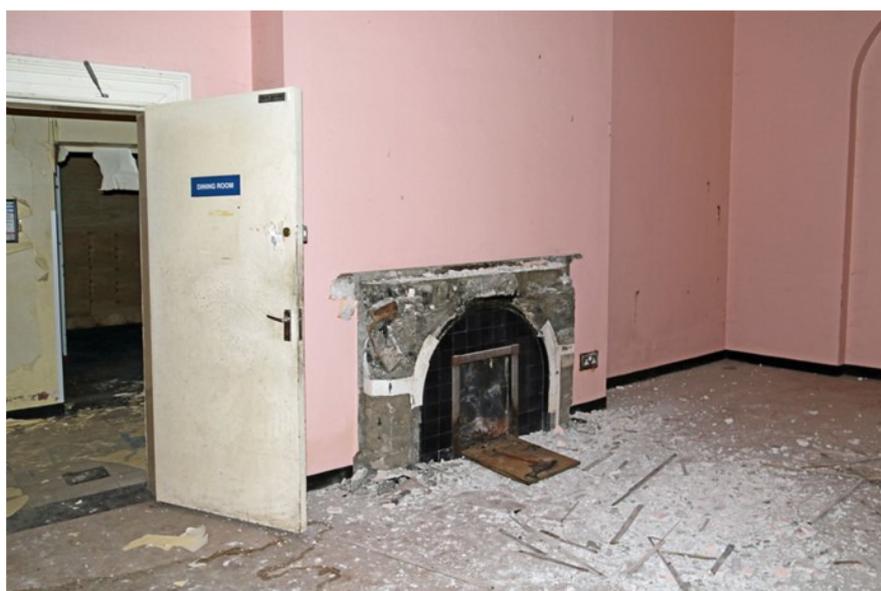
The staff dining room is at the front of the former house, to the west of the original entrance hall. It is lit by two windows, each with moulded-timber architrave and panelled shutters. The room is entered via a twentieth-century hollow door set in a moulded-timber architrave. There is a chimneybreast in this room, while the chimneypiece is missing. There is a decorative cornice bordered with an egg and dart moulding and this is similar to the cornice in the arts and crafts room.

*Plate 12: Chimneybreast in staff dining room*

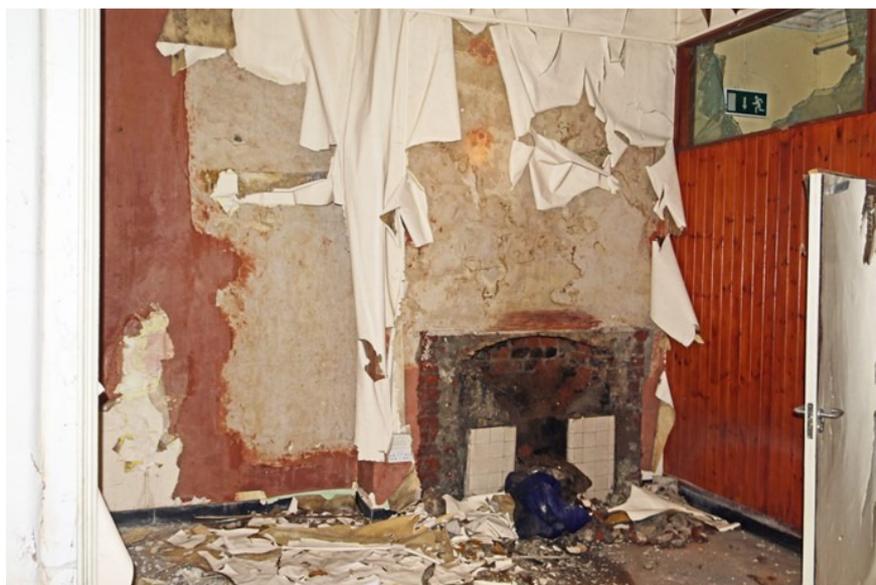
The office is in the south-eastern part of the original house at ground-floor level and has been reduced in size by a timber partition with a glazed upper section, facilitating the provision of the central corridor. Entry is via a twentieth-century hollow door. The room is lit by a single rear-facing window with a moulded-timber architrave; the shutters are missing. A plain run cornice is bordered by an egg and dart moulding. There is a chimneybreast, though the chimneypiece is missing.

*Plate 14: Chimneybreast and partition in office*

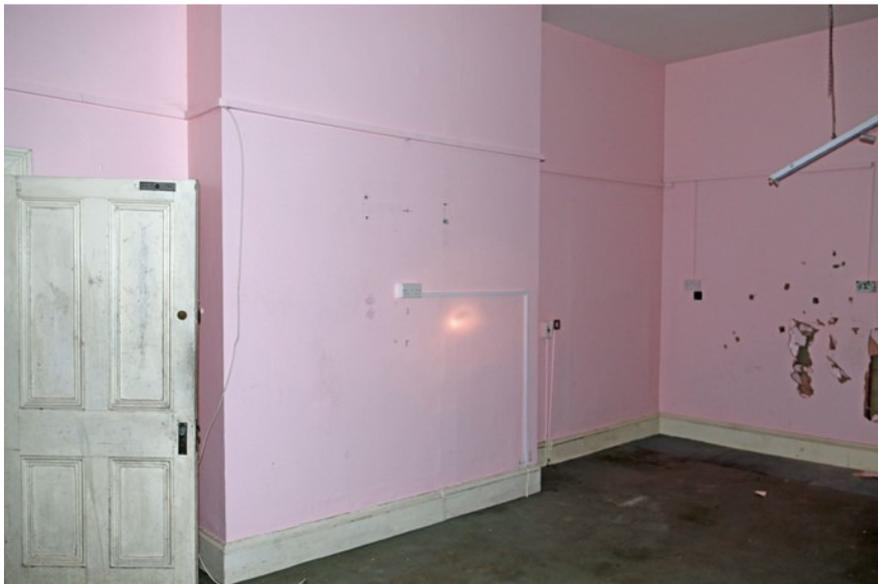
The sitting room is at the front of the first floor, in the north-eastern part of the house. It is lit by two windows, each with a moulded timber architrave, while the shutters are missing. A short partition wall projects slightly from the wall between the windows. The room is entered via a four-panelled door with a moulded-timber architrave. There is a chimneybreast in this room, though the hearth has been stopped up. There is no cornice.

*Plate 20: Door and chimneybreast in sitting room*

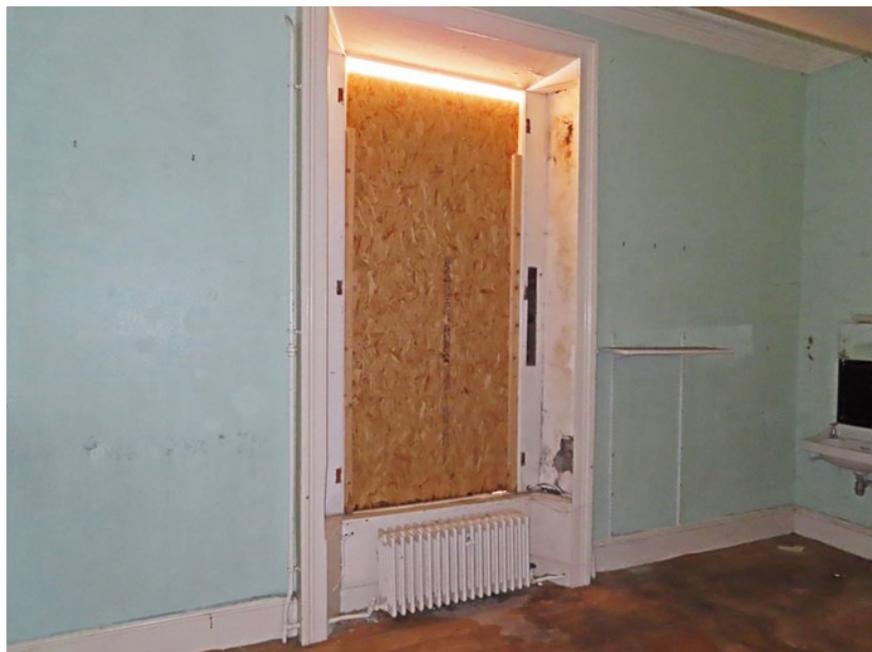
*Plate 25: Window in visitors' room*

The visitors' room is at the rear of the original house, in the south-eastern part. It is separated from the corridor by a twentieth-century stud partition in which several areas of plasterboard have been damaged. The room is lit by a single window set in a moulded-timber architrave, while the shutters are missing. The room is entered via a four-panelled door set in a moulded-timber architrave. There is a chimneybreast in this room, though the hearth has been stopped up. A plain run cornice runs around three sides of the ceiling. A section of the ceiling has collapsed.

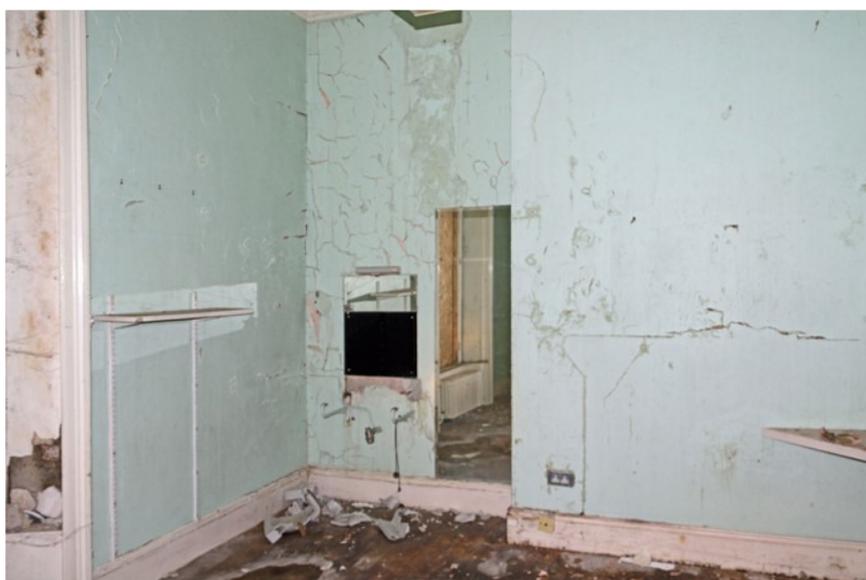
*Plate 26: Chimneybreast in visitors' room*

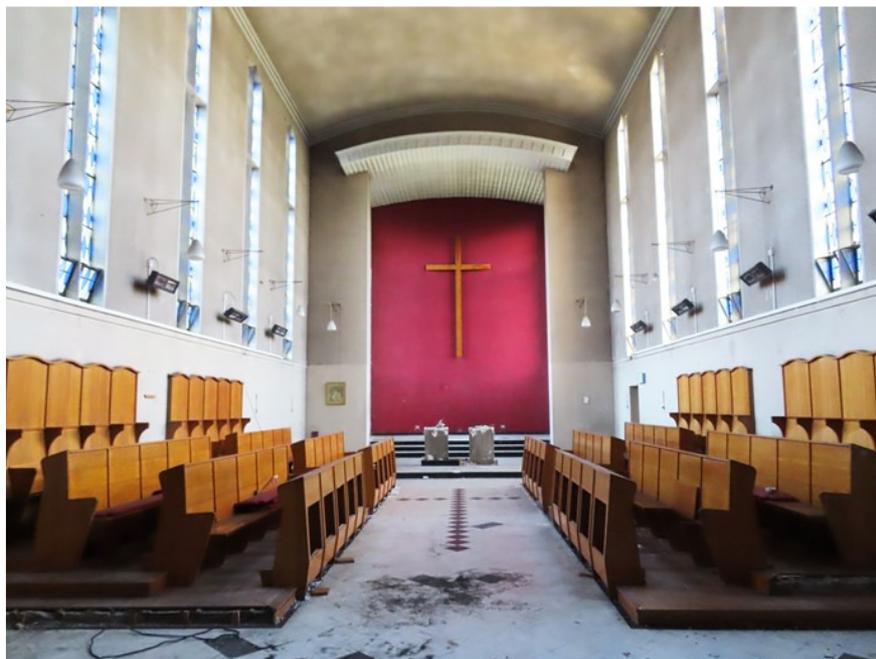
*Plate 38: Interior of chapel*

The chapel is the same height as the rest of the building, though internally it occupies the full height. It is lit at either side of the nave by five lancet windows with cruciform divisions and with a geometrical arrangement of coloured glass. The chancel is glazed on either side, with similar cruciform divisions. The exterior of the end wall of the chancel is faced with brick and has a dedication stone near the base. There are two galleries at the liturgical west end of the chapel, though the access to each is blocked off. The altar is missing. The pews and a confessional remain in place.

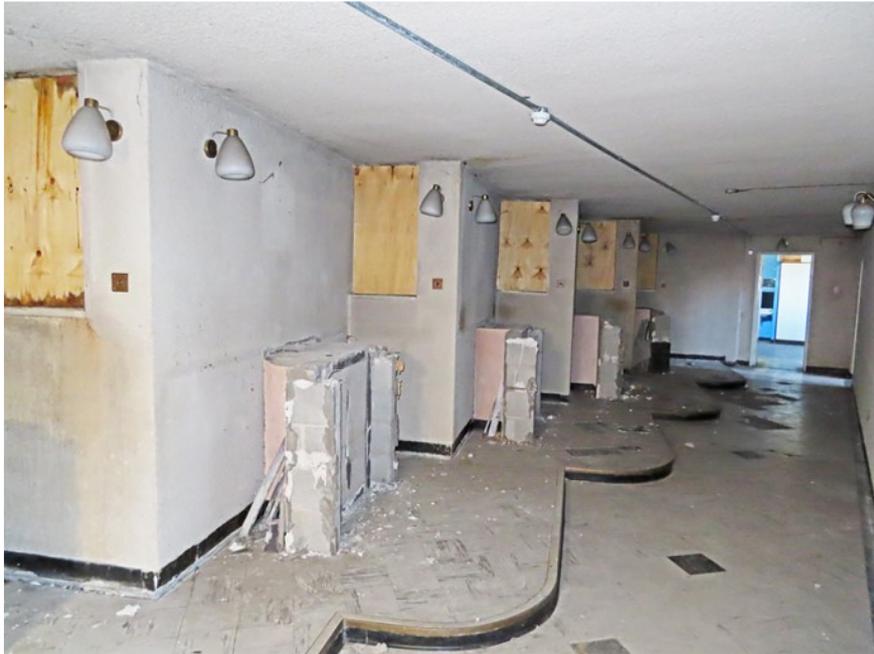
*Plate 40: Side chapel*

To the south of the chapel is a side chapel, which formerly had a series of practice altars. These have now been dismantled. The windows to this chapel are boarded up and the interior is plain.

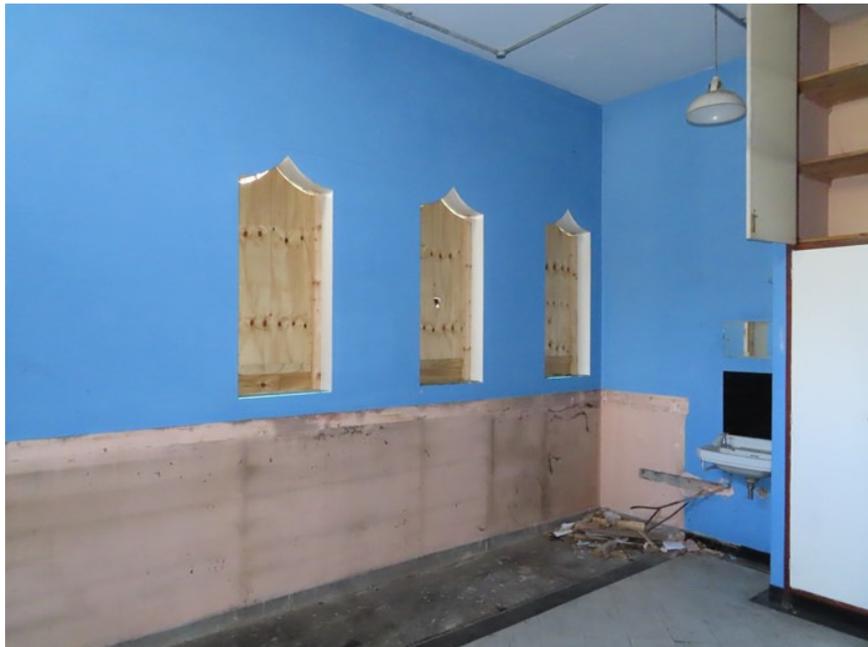
*Plate 41: Vestry*

Also adjacent to the chapel is the vestry. It had vestment cabinets and other joinery that is no longer present.
