Independent Tree Surveys Ltd

Tree Survey & Planning Report  
Residential Development  
Taylors Lane  
Ballyboden  
Dublin 16

March 2023

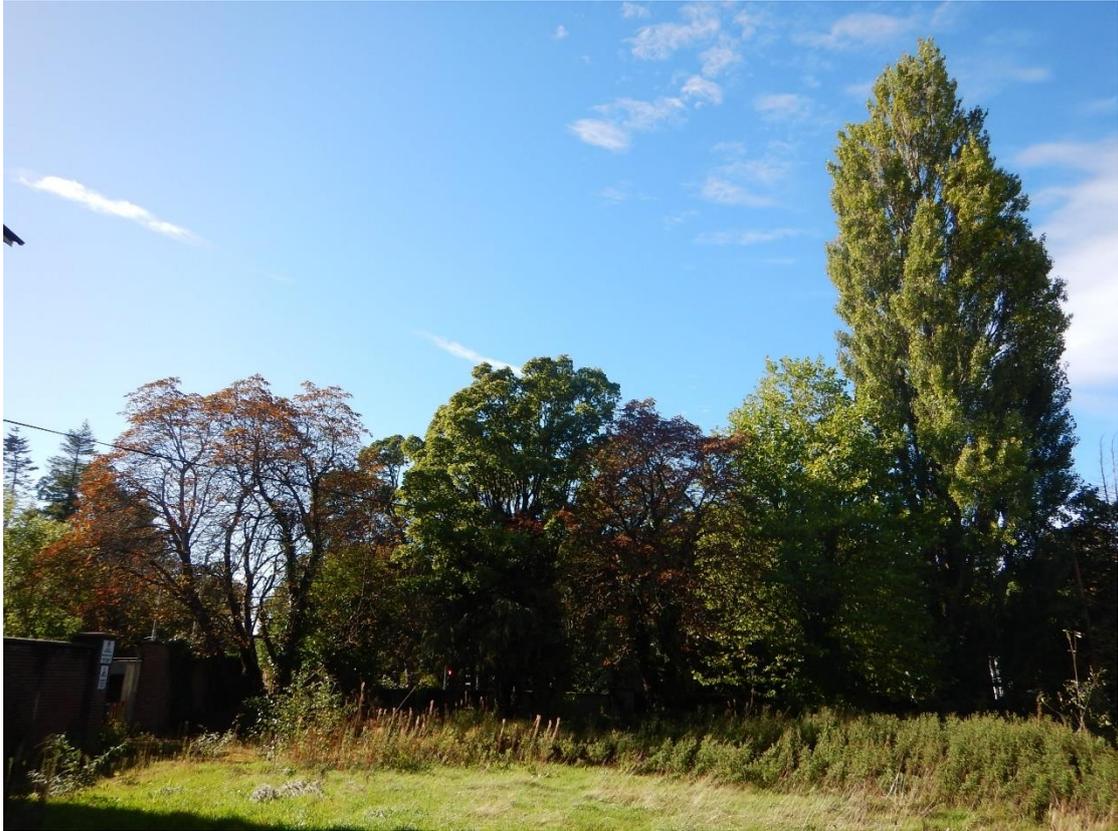
There is a dense treeline along the northern part of the boundary with Taylors Lane, including three very prominent Lombardy Poplar trees (883,891 and 894) that are recommended for further examination to check for internal decay. The treeline also contains several trees in poor condition due to disease and storm damage. More trees are located around the open space between the old buildings and Ballyboden Road to the north; this includes the large Monterey Pine (T909) and Copper Beech (T900). Some of the other trees (notably the Cherry trees) are in poor or bad condition (possibly due to past root damage), others appear to be self-sown and of limited value (such as the cluster tagged 874-876, 902-903). The early mature Cedar (908) has sustained repeated storm damage which has caused significant branch breakage and limits the long-term potential of the tree.

1. Mature trees (878-883) along the Taylor's Lane (western) boundary of the site

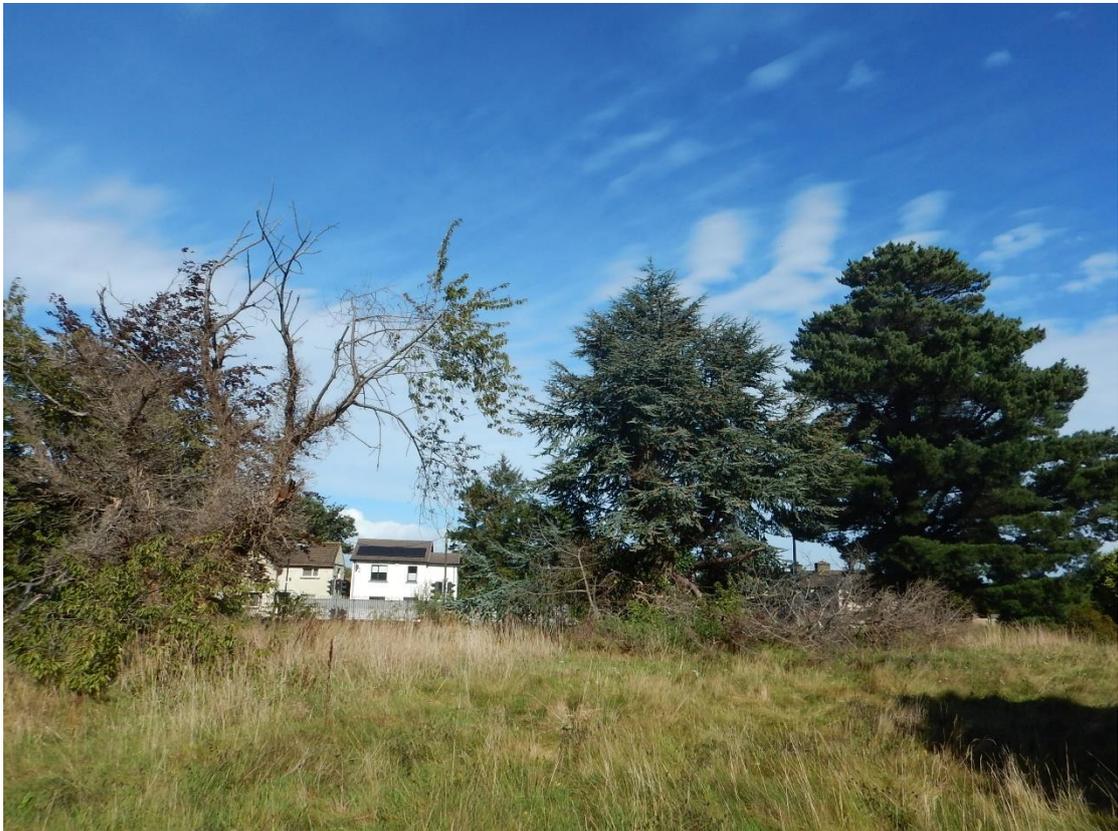
2. Trees in northwest of site, included dying Cherry (905) on the left, storm damaged Cedar (908) and tall Pine (909) to the right

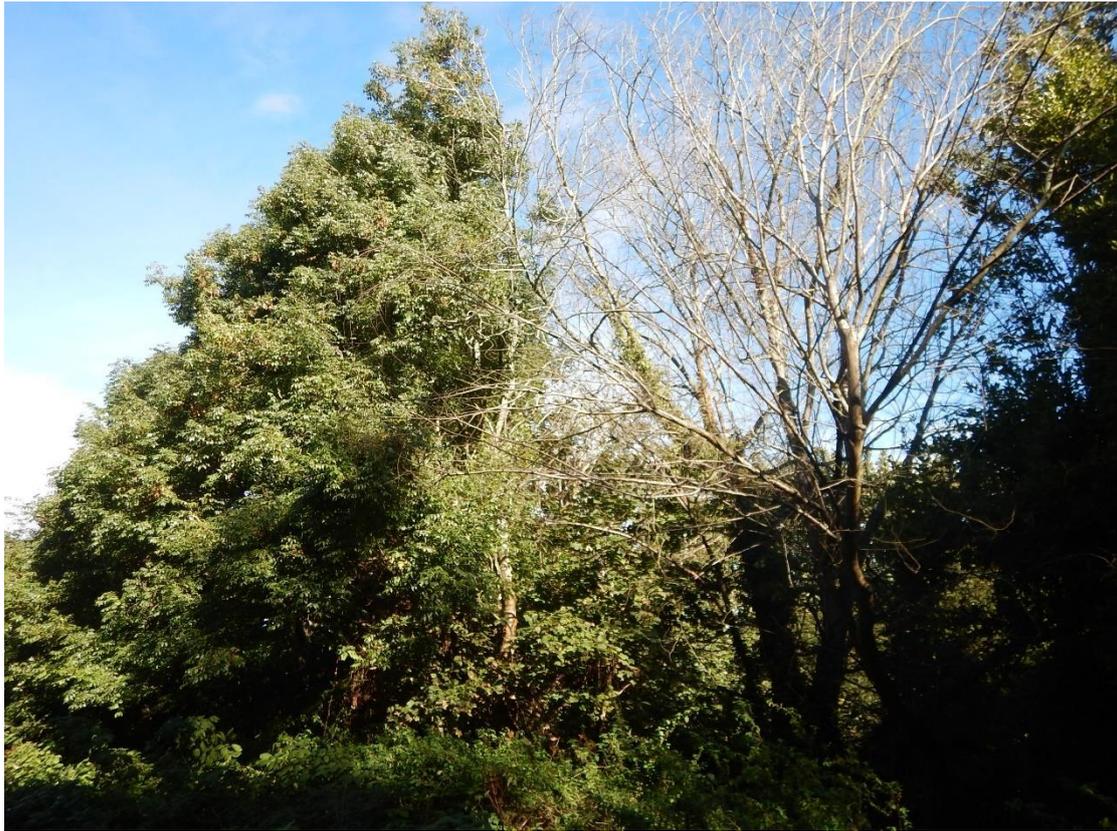
All of the Ash trees on the site are showing signs of Ash Dieback disease (ADB); unfortunately, these trees are likely to decline in health and condition, and most will die within a few years. The Wych Elm trees growing on the site have all been affected by Dutch Elm disease, with trees 923.1 and 926 now standing dead.

3. Elm (926) killed by Dutch Elm disease on the right, Ash with signs of crown dieback caused by Ash Dieback disease to left

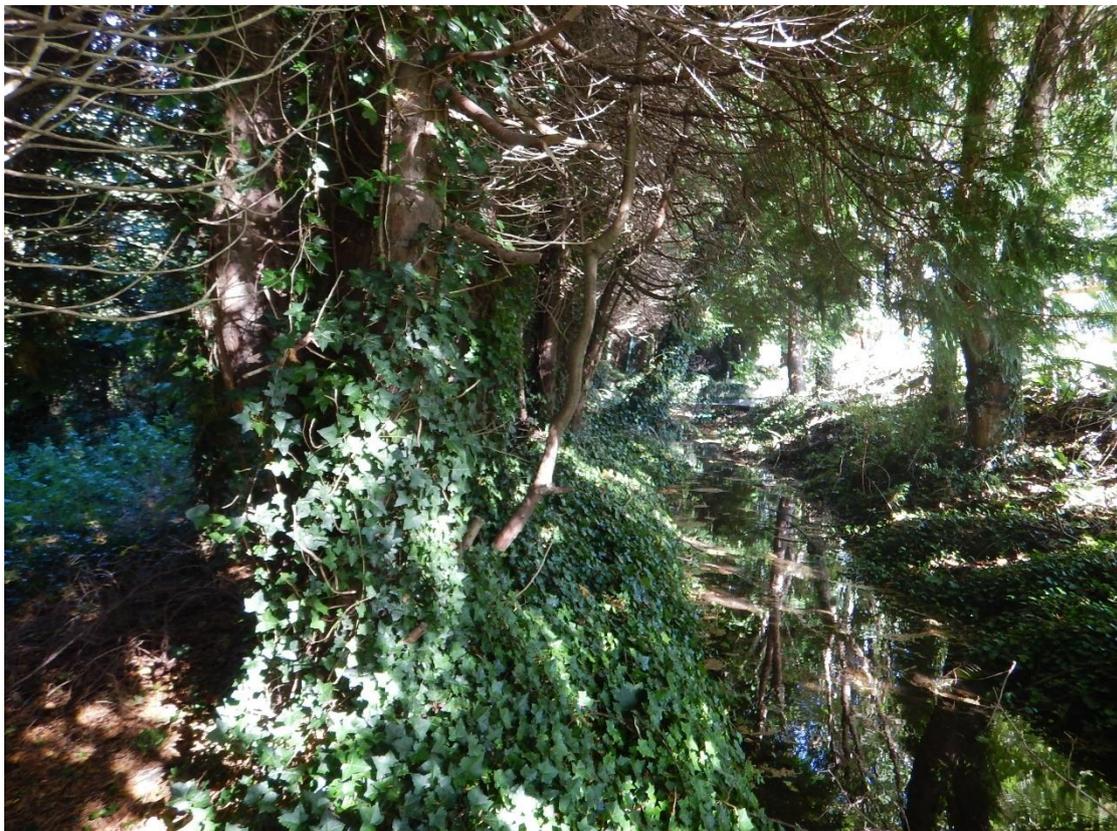
4. Heavy shade cast by Cypress trees (group G21) along small stream/mill race on southern boundary

The plans for the new development include for the removal of the overgrown Cypress treeline (G21) that runs along the southern boundary region of the site and other trees planted along the bank below the small watercourse. This is proposed as part of plans to improve the conservation value of the riparian corridor by replacing the mono-cultural stand of conifers with a mix of species able to benefit from the vastly improved growing conditions created by the removal of the heavy shading from the Cypress trees. This work will involve the removal of a considerable number of individual trees and open up the southern boundary region in the short term, however, the trees are of low individual value and the works should bring about a net improvement of tree and vegetation quality over time and into the future.

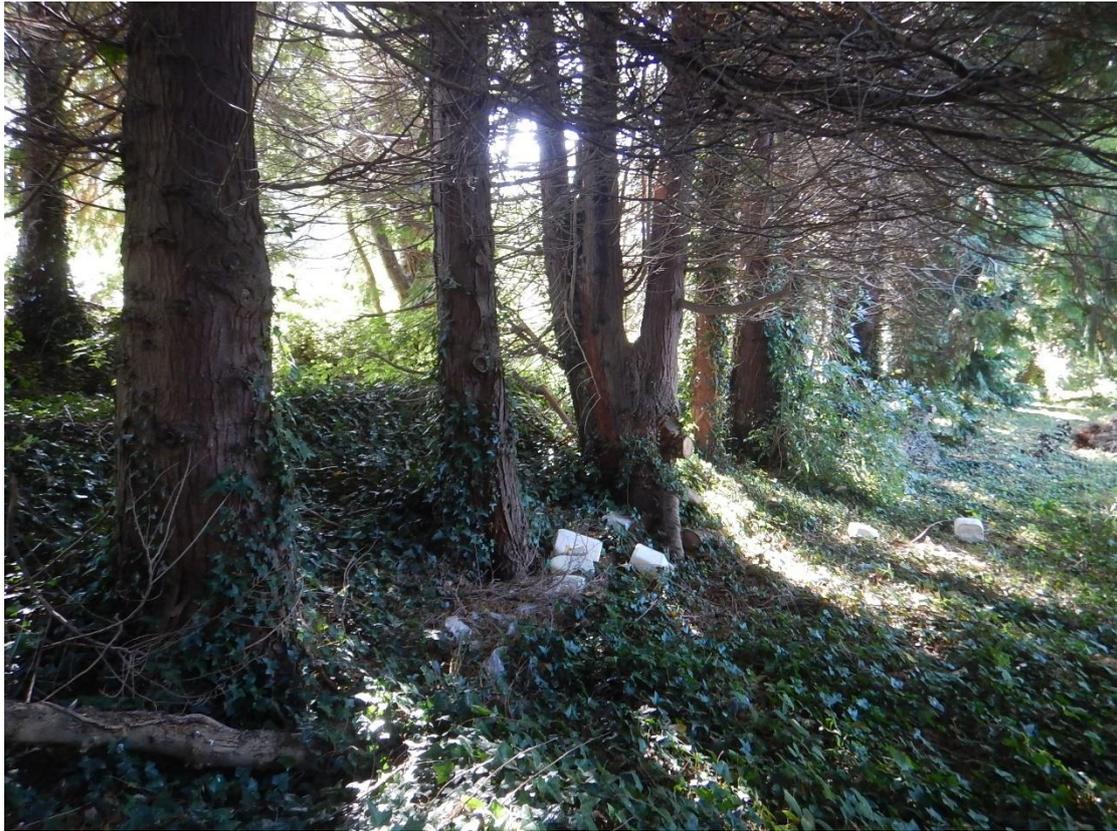
5. Heavy shade cast by Cypress trees (group G21) along the southern boundary of the site
