Arboricultural Report

Tree Survey,
Arboricultural Impact Assessment &
Arboricultural Method Statement

Railpark West

240924-PD-11-A

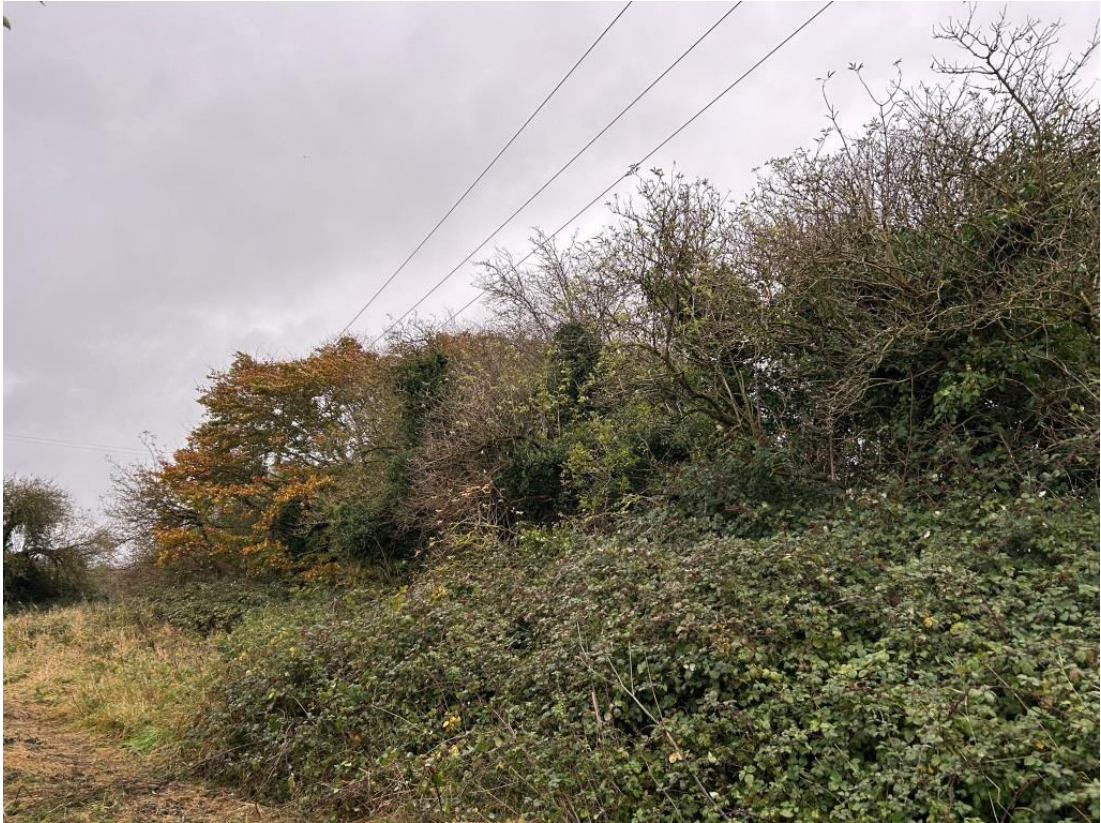
Photo 1: View showing native hedgerow H66 and the veteran beech T59.

1 Rubus fruticosus s. (Blackberry/Bramble)																				
	1 Hedera helix (Common Ivy)																				
	1 Crataegus monogyna (Common Hawthorn/Quick/May)																				
Tree T59	1 Fagus sylvatica (Common Beech)	13.0	130	1		8.0		8.0		8.0		9.0	1.0		Ancient / Veteran	Structural condition Poor. Physiological condition Fair. Access to inspect base - Restricted / obscured. Arboricultural work - Historic. Crown conflict - Structure / boundary / wire / tree. Decay / structural defect - Extensive. Decay / structural defect - Principal stems. Habitat - High value. Ivy or climbing plant. Tree is situated beneath overhead electrical wires. It has a significant quantity of decay with an open cavity within the main stem. Due to its location, it is likely a regrown pollard that has been periodically topped. It is of value due to its old age and biodiversity value. It should only be retained within a low target area. Unable to inspect tree closely due to ivy cover.	28/10/2024	706.9	15.0	10-20	B3

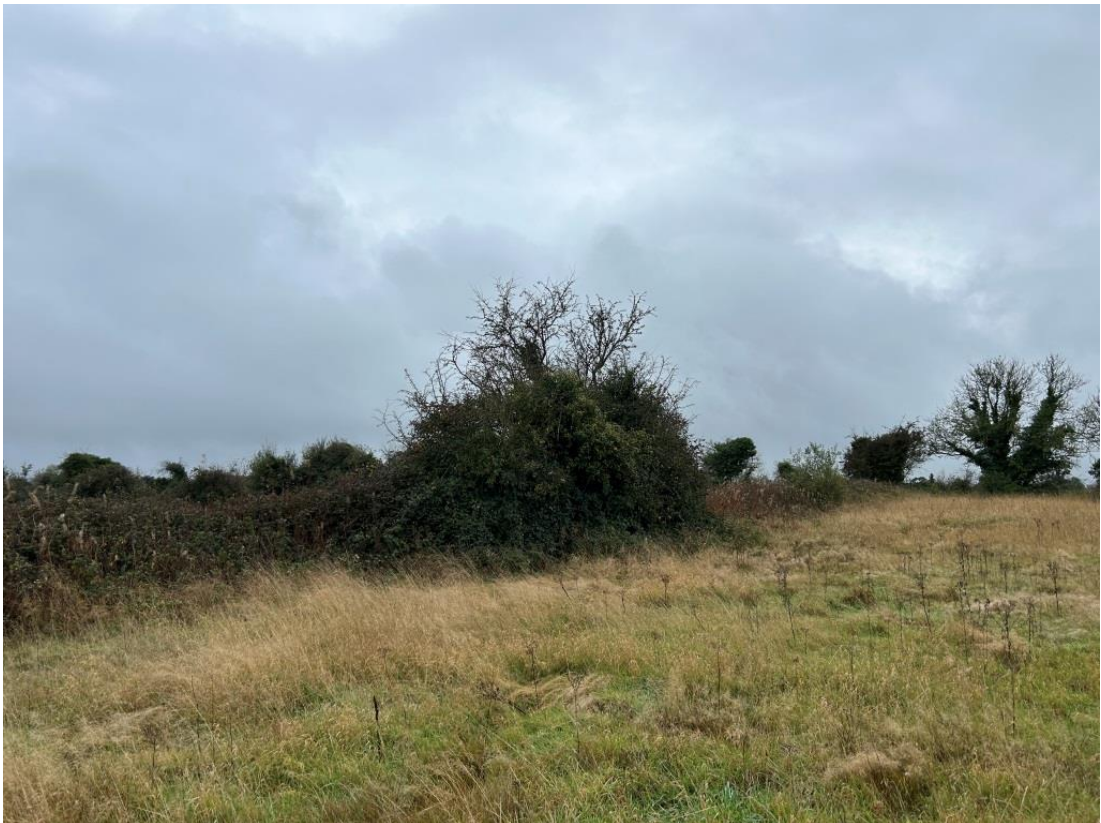
Photo 2: View showing the low quality internal hedgerow that is predominantly bramble.

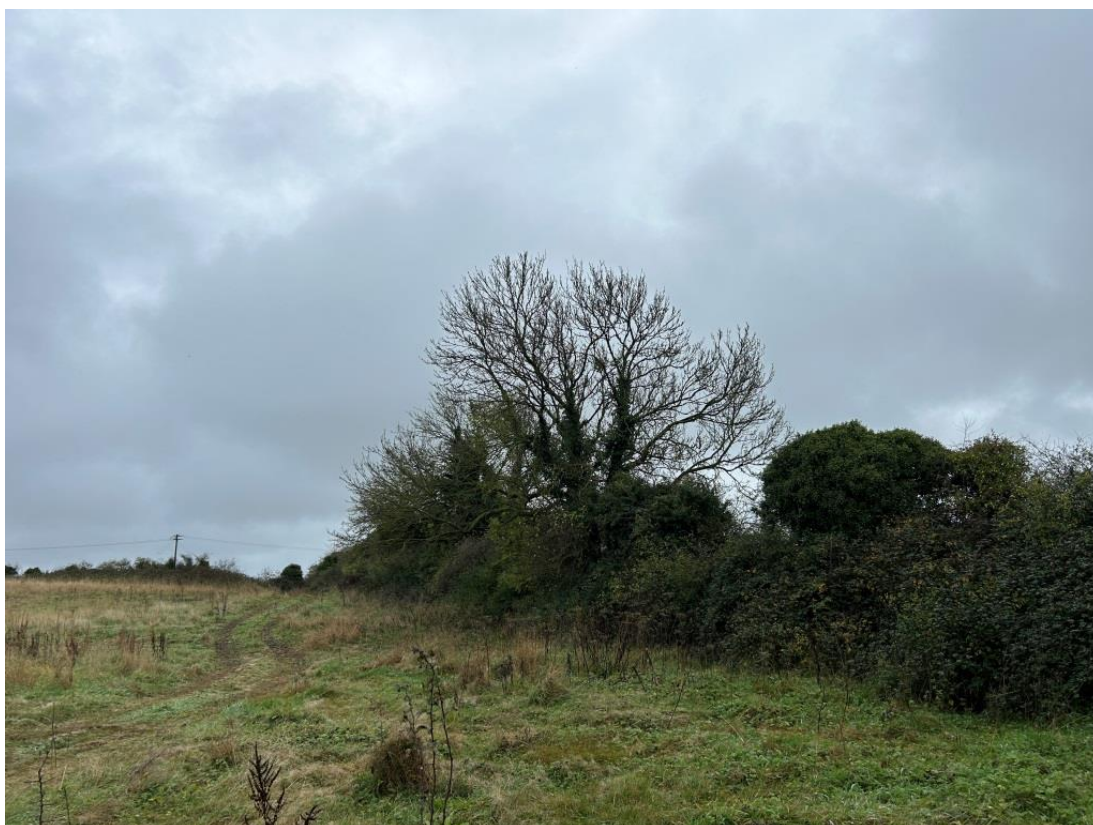
Photo 3: View showing the native hedgerow H25 and ash trees T22 to T24 located along the southern boundary.

Tree T23	1 Fraxinus excelsior (Ash)	13.0	70 COM	4	7.0		7.0		6.0		6.0		3.0		Mature	Structural condition Poor. Physiological condition Poor. Access to inspect base - Not possible. Die-back - Throughout crown. Decline - Evident / observed. Deadwood - Minor. Ivy or climbing plant. Unable to inspect tree closely due to dense undergrowth. Tree is infected with ash dieback - advanced stages.	28/10/2024	221.7	8.4	0-10	U

- 6.5 It has initially been proposed that the two poor quality (U Category) ash trees infected with the fungal pathogen ash dieback are retained along the southern boundary. It is recommended that the trees be managed through crown reductions rather than removal so that they can be retained for biodiversity reasons. These works are specified within the Tree Work Schedule at Appendix A.

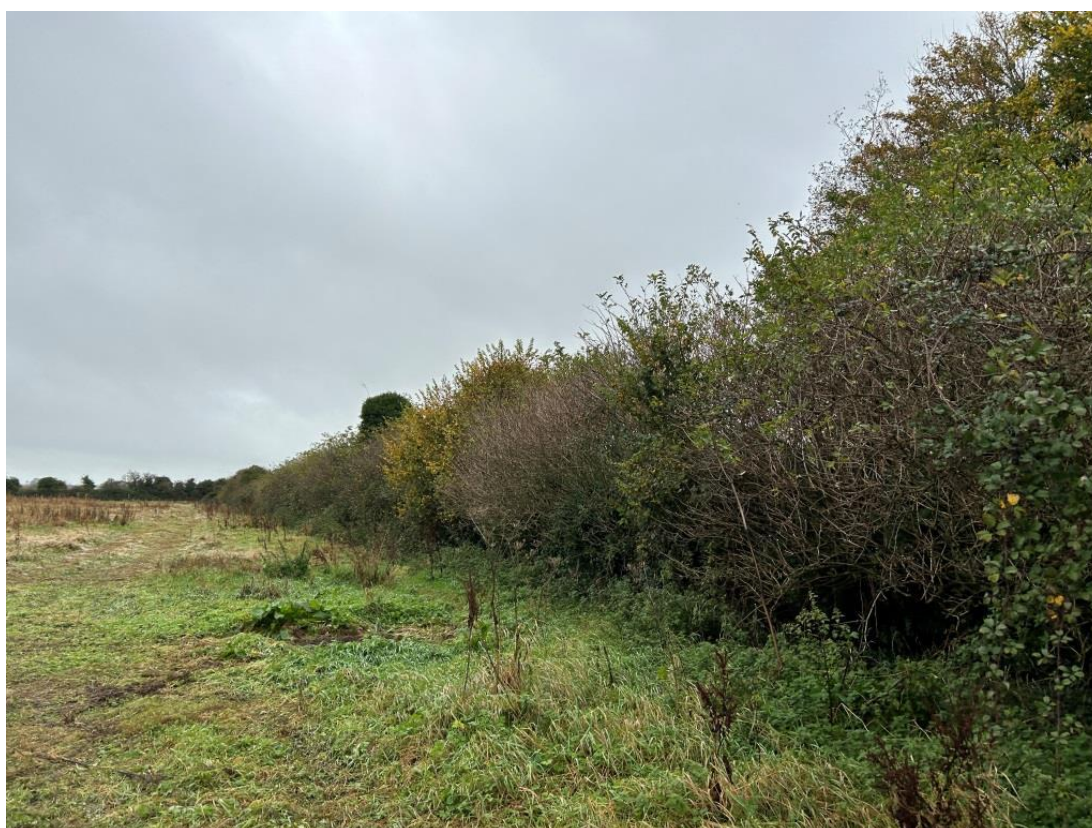
Photo 4: View of the moderate quality eastern boundary hedgerow H46.

Tree ID	No. Species	Height (m)	Stem diameter (cm)	No. of Stems	CROWN SPREAD (m)								Crown clearance (m)	L.B. (m)	Life stage	Condition Notes	Survey date	RPA (m ²)	RPR (m)	Life expectancy (yrs)	BS Category
					N	NE	E	SE	S	SW	W	NW									
Hedge H46	1 Ulmus procera (English Elm)	6.0	30 AVE	1									0.0		Mature	Structural condition Good. Physiological condition Good. Native field boundary hedgerow consisting mainly of elder with some hawthorn in the southernmost section. The northern half of the hedgerow was managed at 2-2.5m and has regrown to approx. 5m. The southern half of the hedgerow has not been managed and is approx. 7-8m in height. Hedgerow appears to be on the boundary line. It is densely stocked and of good landscape value. Stem diameter is average for group. Quantities not recorded, only species mix.	28/10/2024	40.7	3.6	20-40	B2
	1 Sambucus nigra (Elder)																				
	1 Rubus fruticosus s. (Blackberry/Bramble)
