**ARCHITECTURAL HERITAGE  
ASSESSMENT  
AT  
GOOD COUNSEL CENTRE  
TAYLOR'S LANE  
BALLYBODEN  
DUBLIN 16**

**ON BEHALF OF:  
SHANNON HOMES DUBLIN UNLIMITED COMPANY**

**AUTHOR: ROB GOODBODY**

**MARCH 2023**

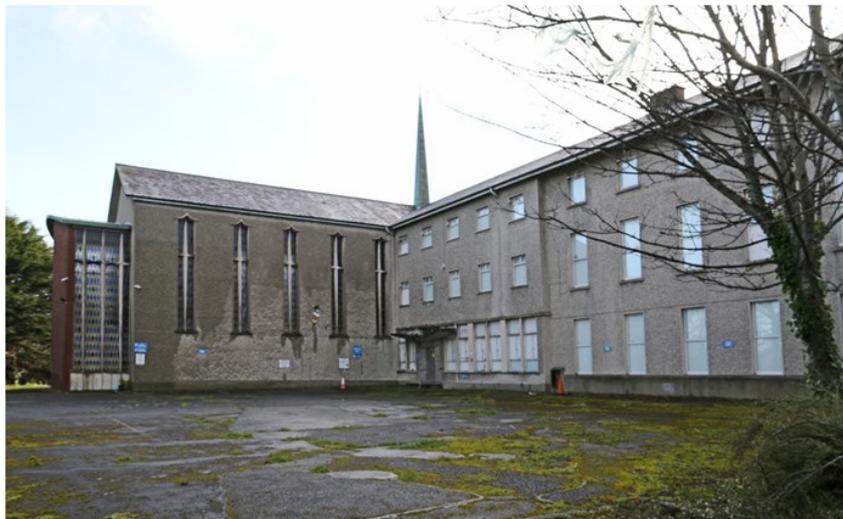
*Plate 1: View eastward across front of building*

The former Good Counsel Centre is a three-storey, multiple-bay, T-shaped building on the southern side of Taylor's Lane and the eastern side of Edmondstown Road. The building has a low-pitched ridged roof with chimney stacks in one part of the long side. The windows are aluminium casements and vary in size and proportion. The building is faced with rough-cast render. At the eastern end the part of the building that projects to the north is the chapel, with long windows and a glazed apse at the northern end.

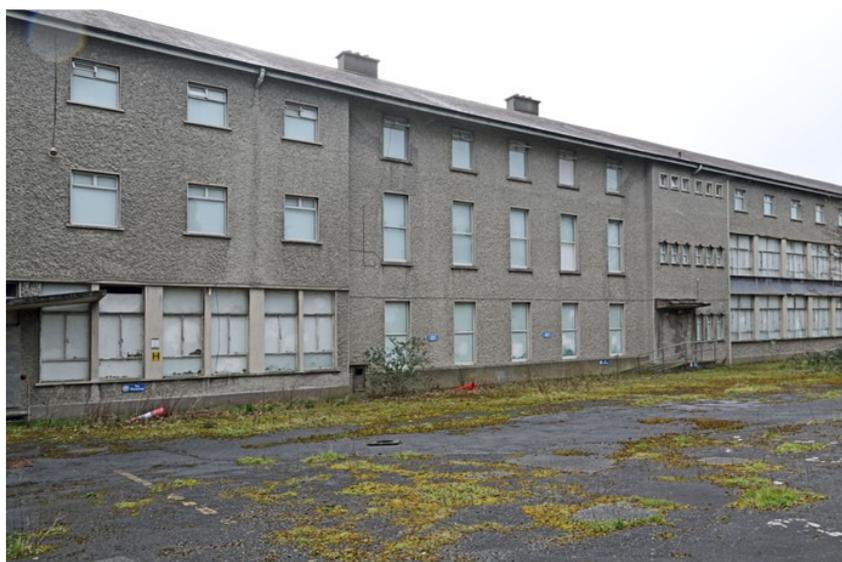
*Plate 2: View westward along northern front of building*

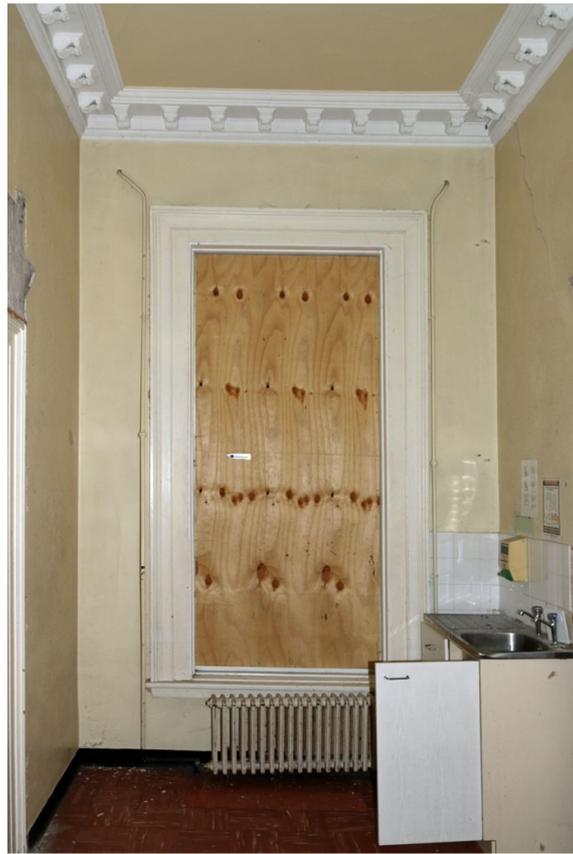
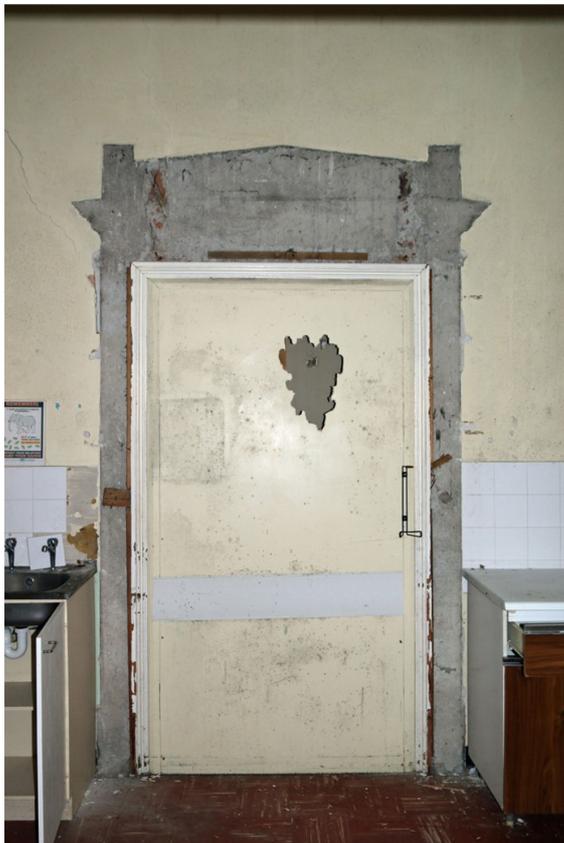
On either side of this room doorways lead into the adjacent rooms, one with a moulded-timber architrave and four-panelled door, the other with a slender architrave and a plain hollow door. In both cases scars on the walls adjacent indicate the former presence of more decorative architraves and overdoors.

*Plate 6: Doorway at side of former entrance hall*

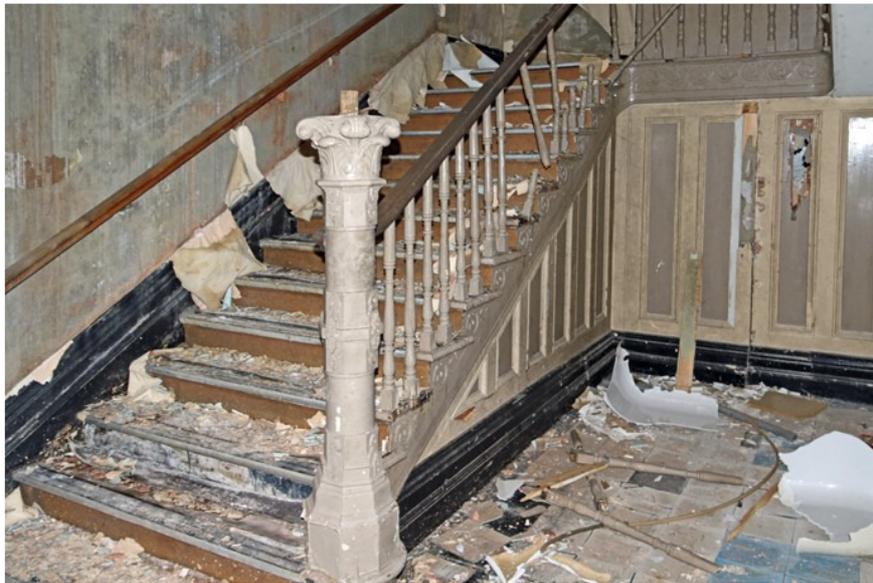
The stair is open string, with fretted tread ends. The balustrade has turned balusters that support a hardwood handrail, though significant numbers of the balusters have been broken. At the foot of the stair is a substantial newel, decoratively carved, though with the upper part missing. The area beneath the stair is enclosed by vertical timber panelling.

*Plate 8: Foot of staircase on ground floor*

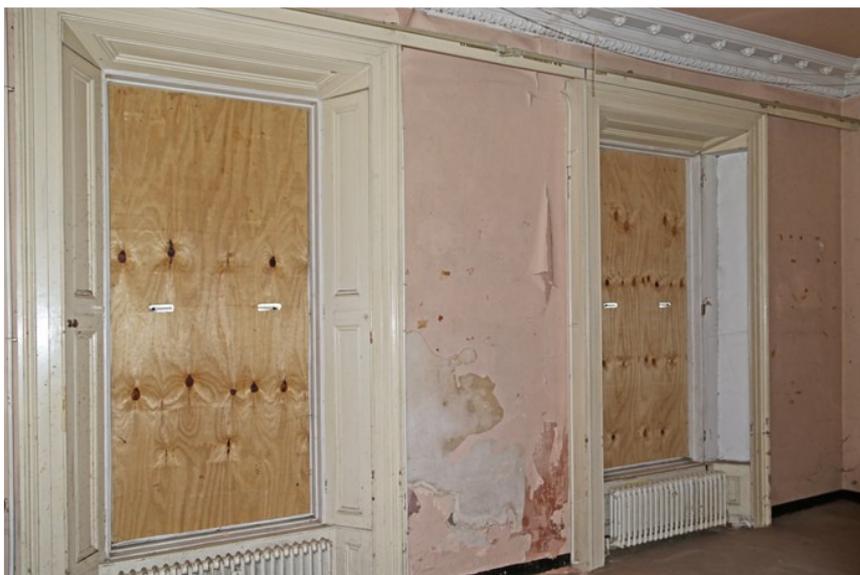
*Plate 9: Windows in arts and crafts room*

The arts and crafts room is to the east of the former entrance hall, at the front of the house. The room is entered via a four-panelled door set in a moulded-timber architrave. The room is lit by two windows, with moulded-timber architraves; the shutters are missing. The doorway from the former entrance hall is not seen on this side of the wall. The room has a decorative cornice, edged with egg and dart moulding. There is a chimneybreast, while the chimneypiece is missing.

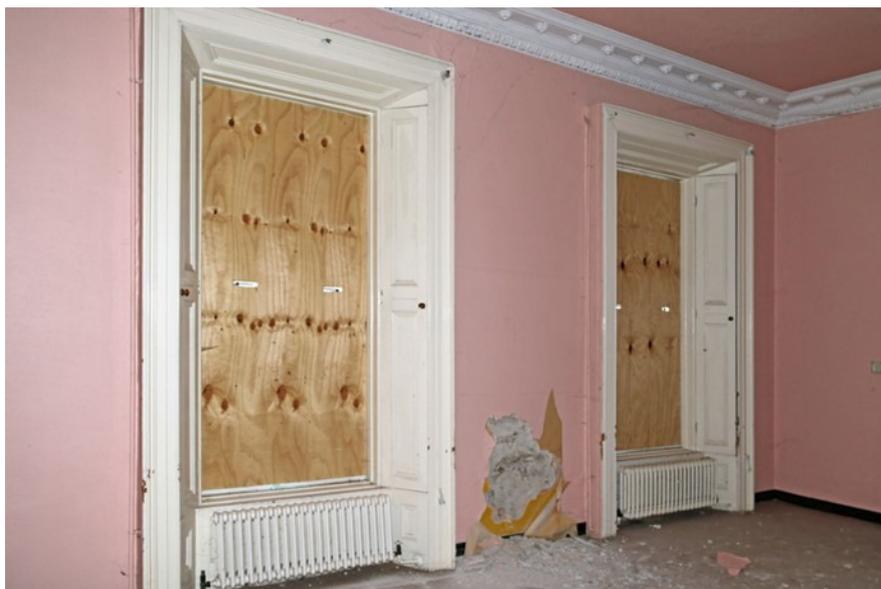
*Plate 11: Windows in staff dining room*

The staff dining room is at the front of the former house, to the west of the original entrance hall. It is lit by two windows, each with moulded-timber architrave and panelled shutters. The room is entered via a twentieth-century hollow door set in a moulded-timber architrave. There is a chimneybreast in this room, while the chimneypiece is missing. There is a decorative cornice bordered with an egg and dart moulding and this is similar to the cornice in the arts and crafts room.

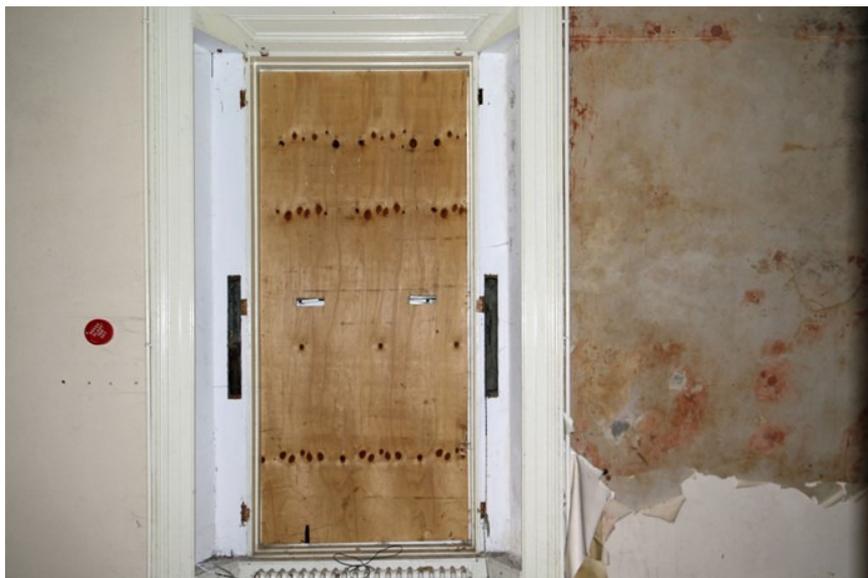
*Plate 13: Window in office*

The office is in the south-eastern part of the original house at ground-floor level and has been reduced in size by a timber partition with a glazed upper section, facilitating the provision of the central corridor. Entry is via a twentieth-century hollow door. The room is lit by a single rear-facing window with a moulded-timber architrave; the shutters are missing. A plain run cornice is bordered by an egg and dart moulding. There is a chimneybreast, though the chimneypiece is missing.

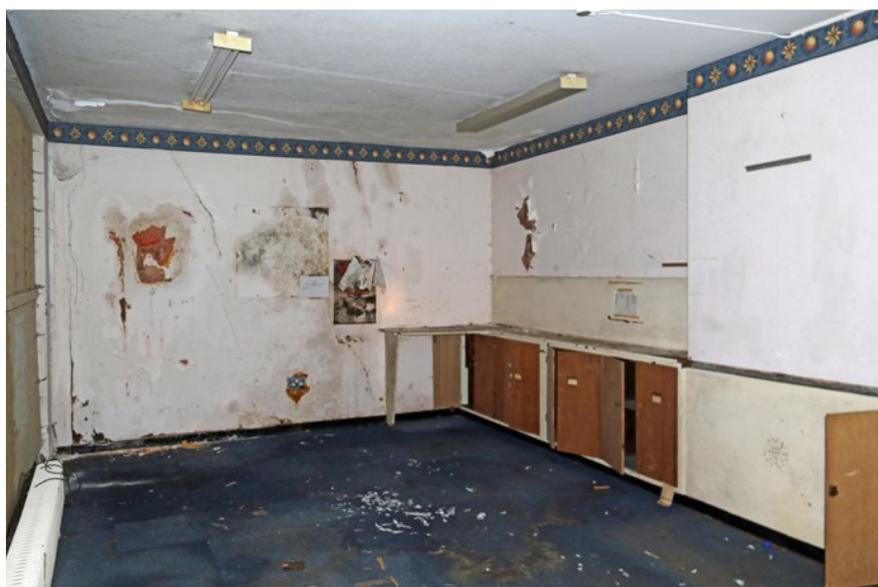
*Plate 15: Rear arts and crafts room*

There is a second arts and crafts room at the rear of the ground floor, in the two-storey element at the south-west of the original house. This room lacks the traditional features seen in the other rooms in the original house and appears to have been rebuilt. The windows are boarded up, but appear to have been continuous, or nearly so, along the southern façade. There are no cornices, shutters, traditional architraves or doors, though there is a chimneybreast with no hearth or chimneypiece.

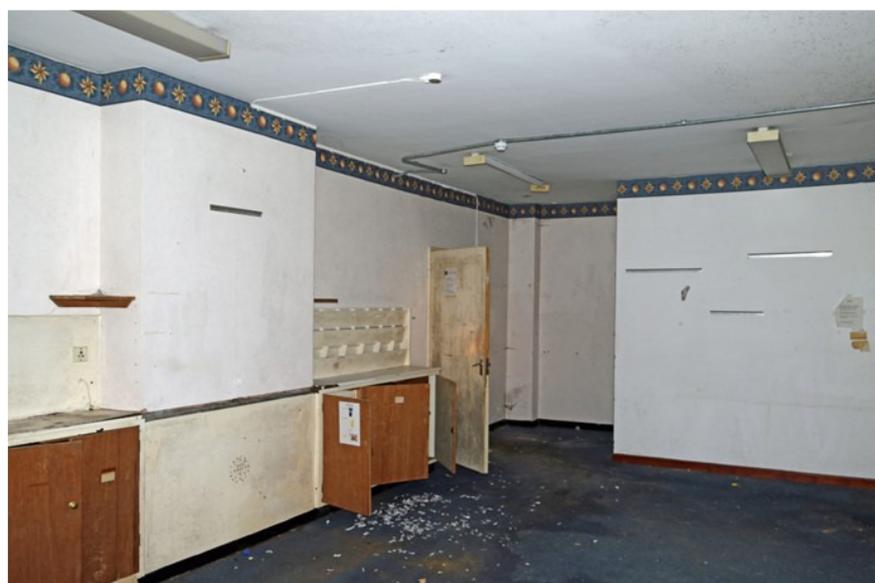
*Plate 16: Rear arts and crafts room*

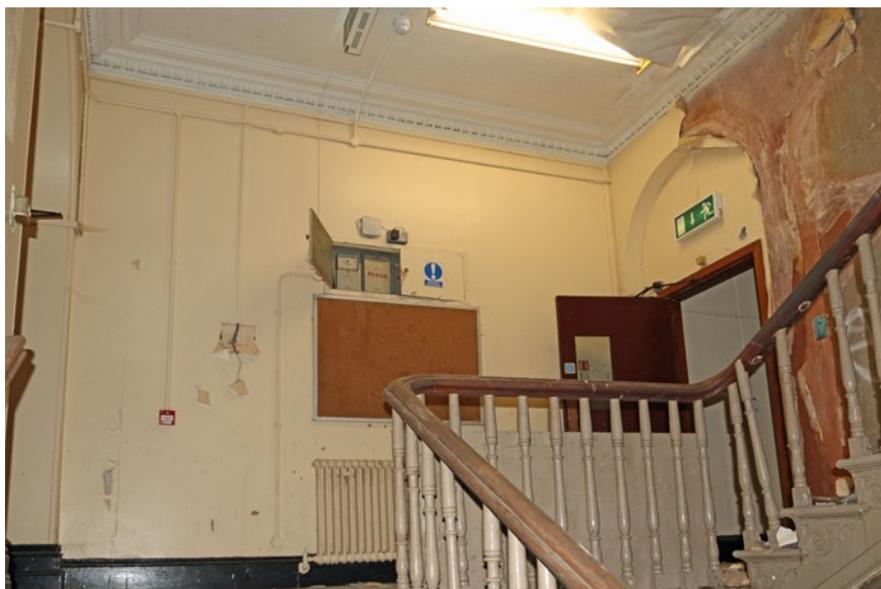
*Plate 17: Staircase at first-floor landing*

The staircase continues up from the ground floor to the first-floor landing and onwards. It is lit at the turn of the stair between ground and first floors by a one-over-one timber sliding sash window set in a moulded-timber architrave with panelled shutters. The style of the stair is similar to that described above, at ground-floor level. Above the stair is a plain-run cornice bordered by an egg and dart moulding.

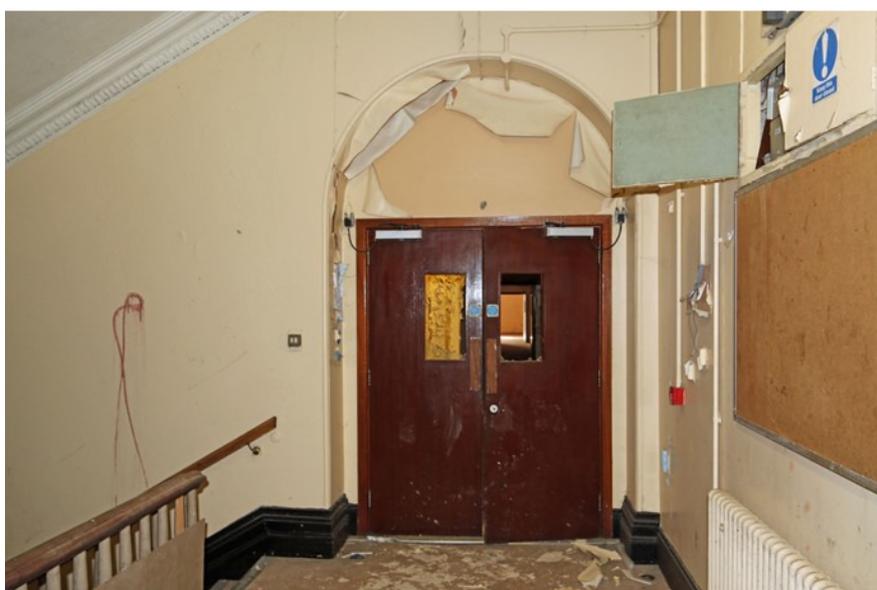
A pair of modern fire doors leads to a corridor to the west from the landing, set in a larger round-headed niche. To the east a single door, also of twentieth-century date, leads to another corridor.

*Plate 18: Doorway to the west of landing*

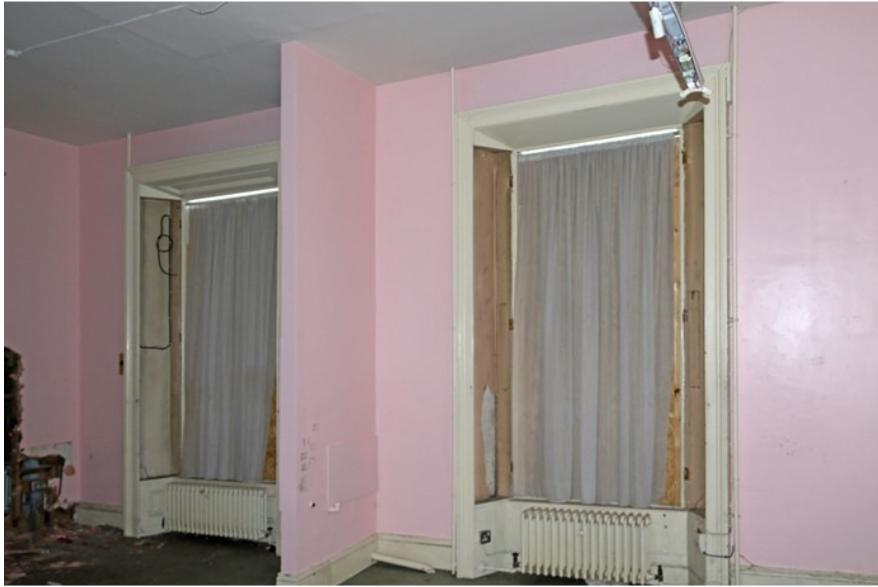
*Plate 19: Windows in first floor sitting room*

The sitting room is at the front of the first floor, in the north-eastern part of the house. It is lit by two windows, each with a moulded timber architrave, while the shutters are missing. A short partition wall projects slightly from the wall between the windows. The room is entered via a four-panelled door with a moulded-timber architrave. There is a chimneybreast in this room, though the hearth has been stopped up. There is no cornice.

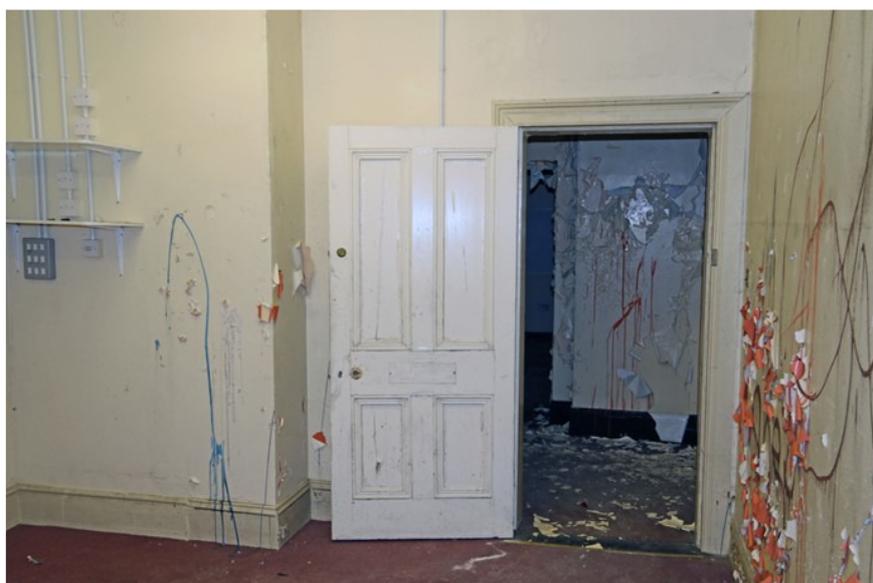
The photographs above and below show the westernmost therapy room, which is lit by a single window with moulded-timber architrave, while the shutters are missing. A chimneybreast has no chimneypiece or hearth. There is no cornice. The door is four-panelled.

*Plate 22: Eastern therapy room*

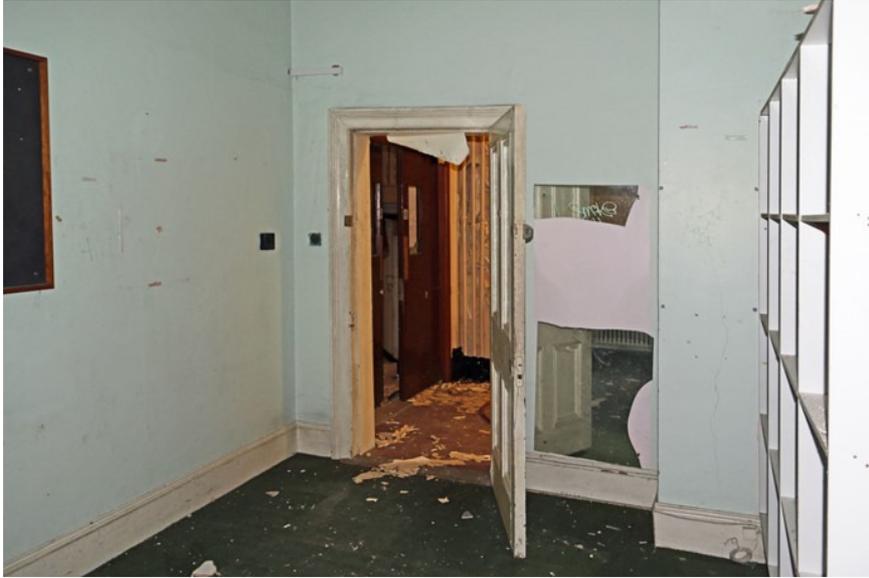
*Plate 23: Central therapy room on first floor*

The central and eastern of the three first-floor therapy rooms are joined by a doorway cut through an original masonry wall. This pair of rooms is entered via a four-panelled door set in a moulded-timber architrave. Each of the two rooms has a window set in a moulded-timber architrave, while the shutters are missing. There is no cornice.

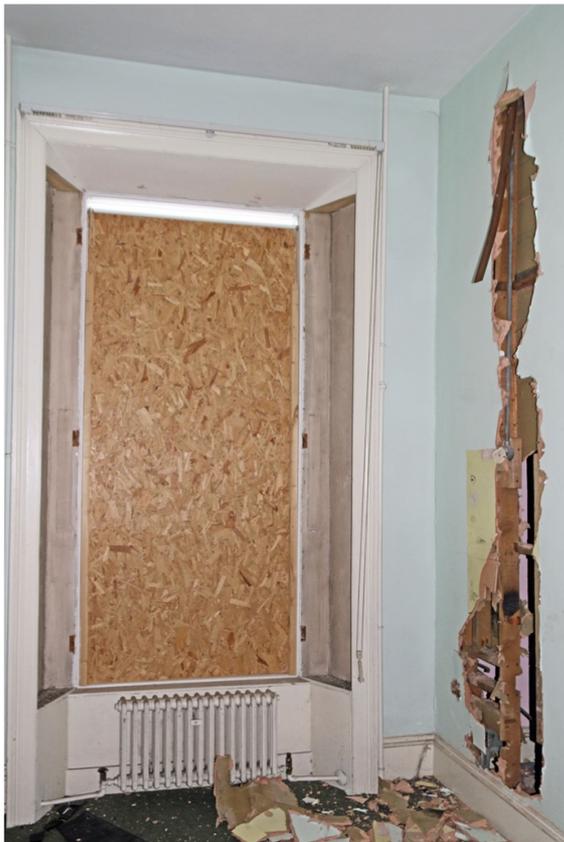
*Plate 24: Window in therapy room*

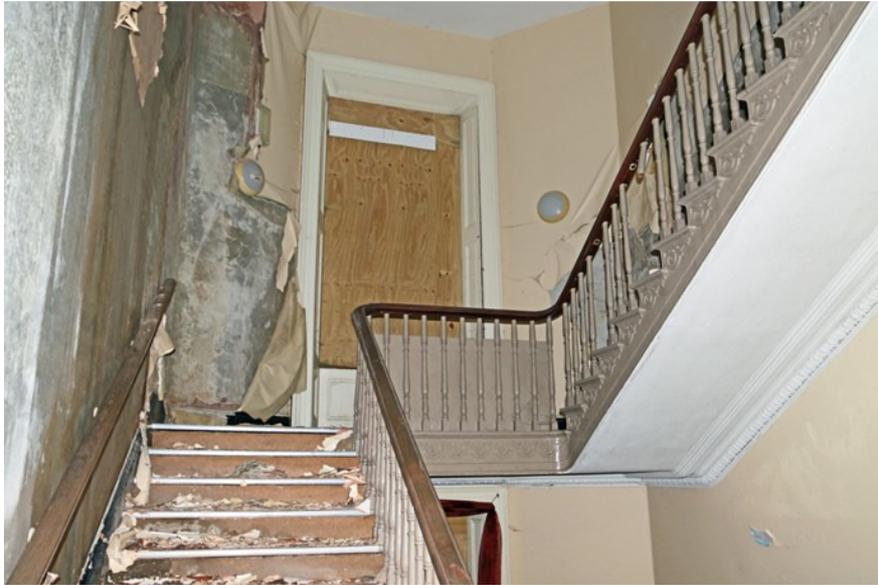
*Plate 27: Staircase leading to second-floor*

The staircase runs up to the top floor without change of style. At the top the balustrade, with its turned balusters and its handrail, run across the margin of the landing. As with the floor below, the stair turns in the canted bay at the rear of the former house, where it is lit by a one-over-one timber sliding sash set in a moulded timber architrave and with panelled shutters. There is no cornice above the staircase and the ceiling is flat, except for a beam crossing above the balustrade.

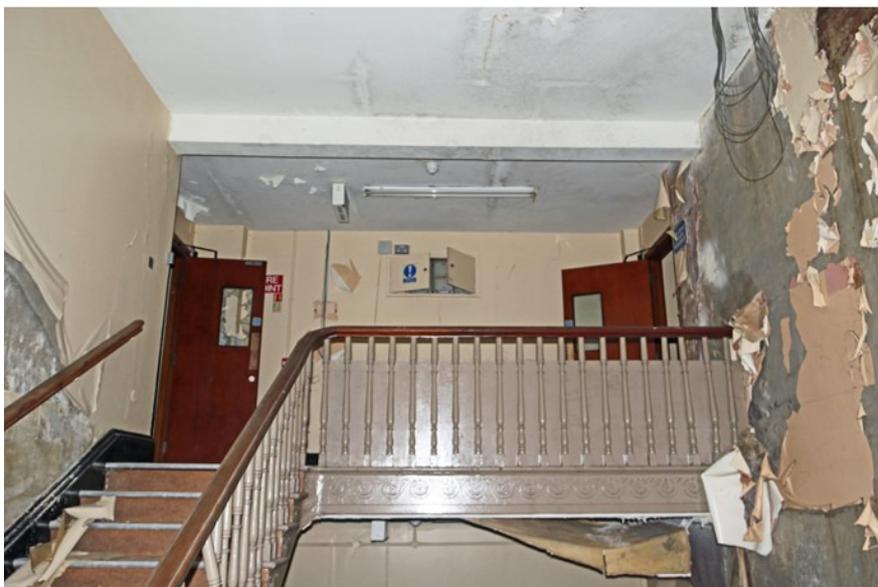
*Plate 28: Staircase at second-floor level*

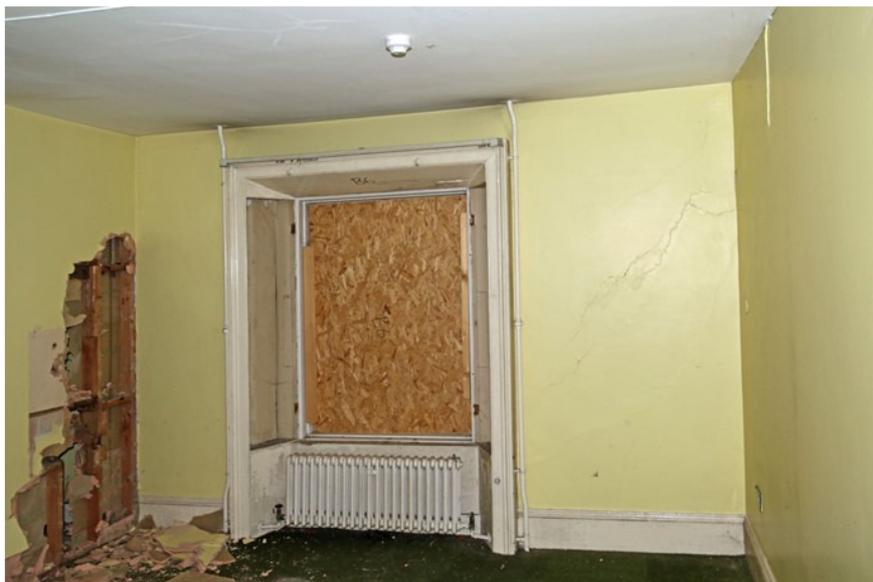
*Plate 29: Bedroom at eastern end of top floor*

The front of the original house has been divided into five rooms at second-floor level, four being bedrooms, while the fifth was a small sitting room. Each is lit by a window set in a moulded-timber architrave, while the shutters are missing. The rooms are accessed from the corridors by just three doors, each of which is four-panelled and set in a moulded-timber architrave. There are three openings between the bedrooms, one of which has a modern fire door, while the others have no door or frame. There are no chimneypieces or cornices at this level.

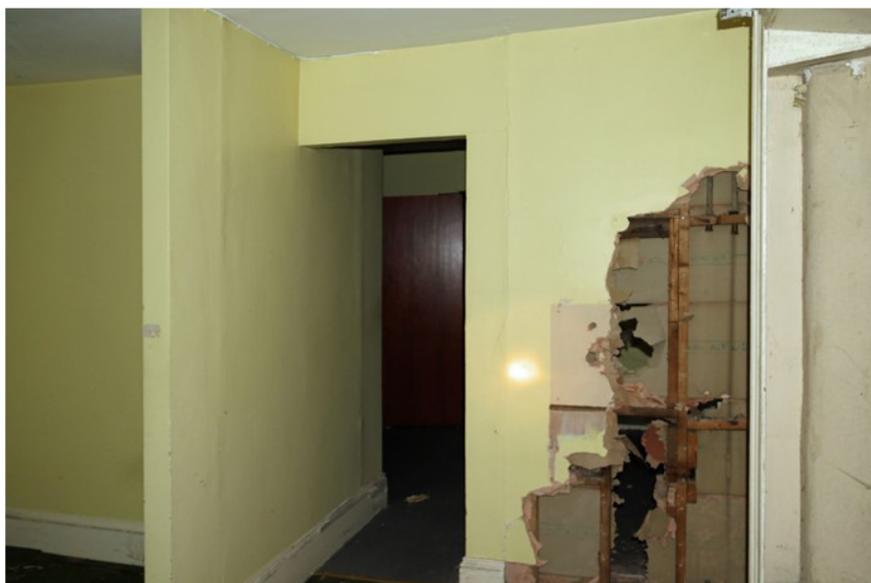
*Plate 30: Doorway between bedrooms*

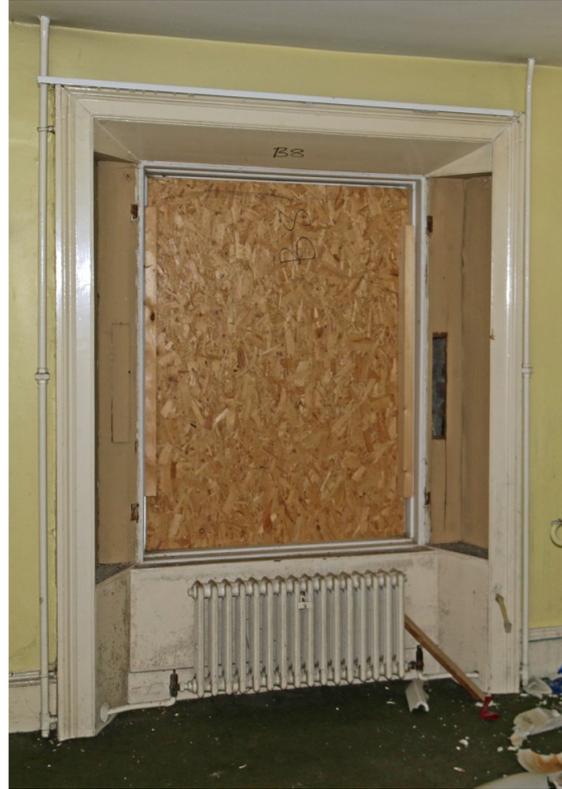
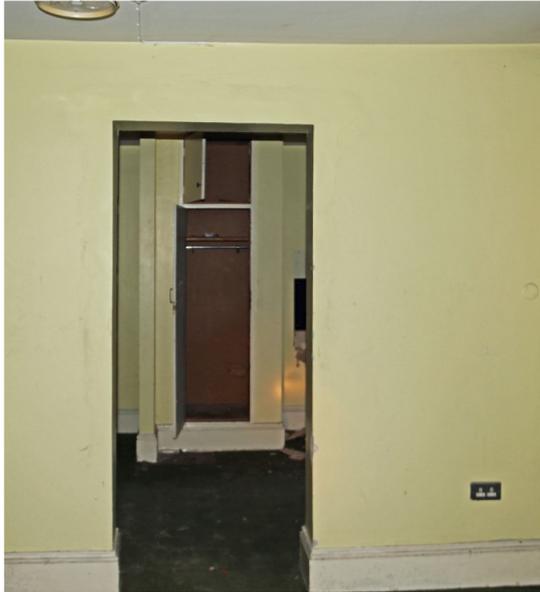
*Plate 31: Bedroom window*

*Plate 32: Doorway between bedrooms*

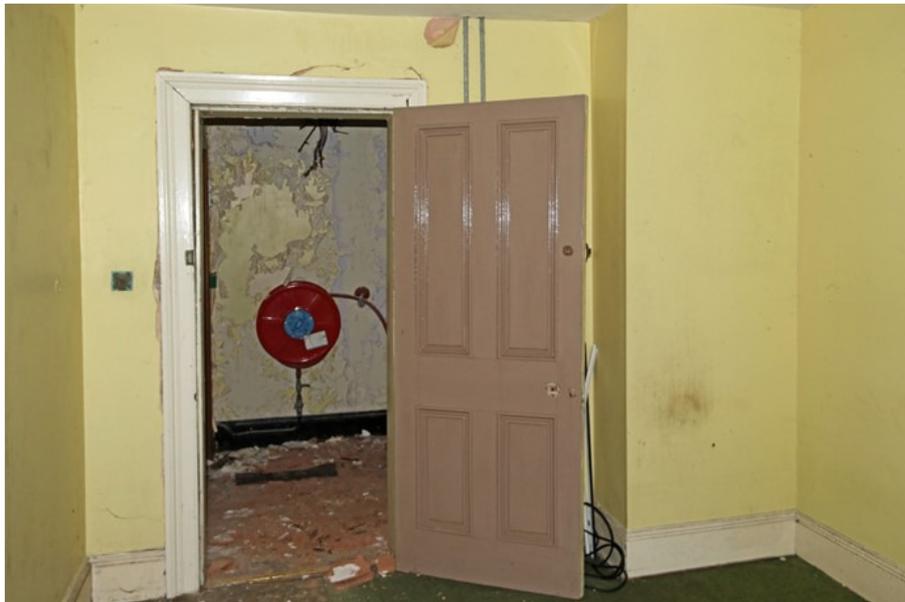
*Plate 33: Bedroom door*

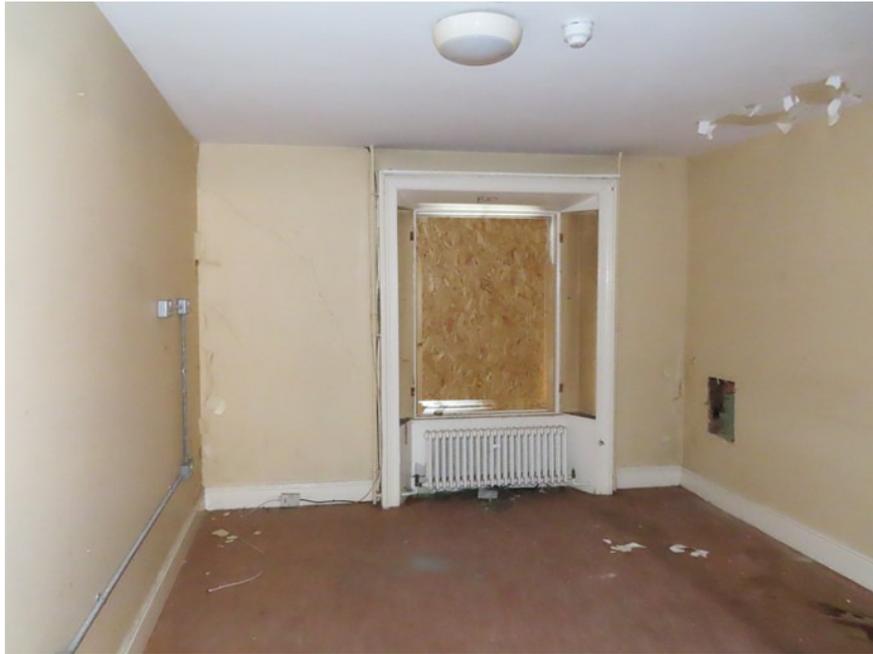
*Plate 34: Window in small sitting room*

The small sitting room at the front of the top floor has one window, as noted above, with an architrave but no shutters. The partition wall between this room and the adjacent bedroom meets a chimneybreast, though the hearth is stopped up and there is no chimneypiece.

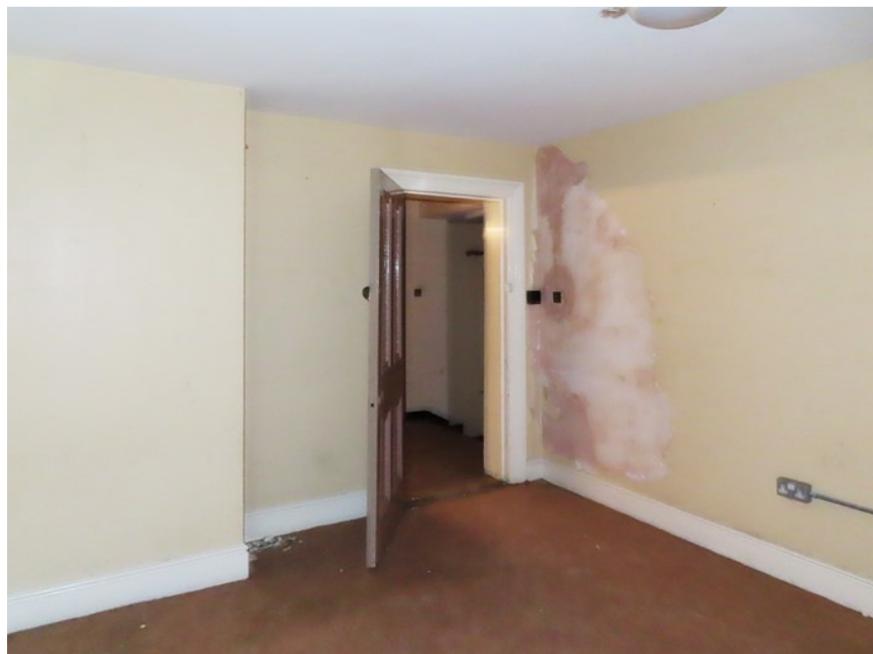
*Plate 35: Doorway to small sitting room*

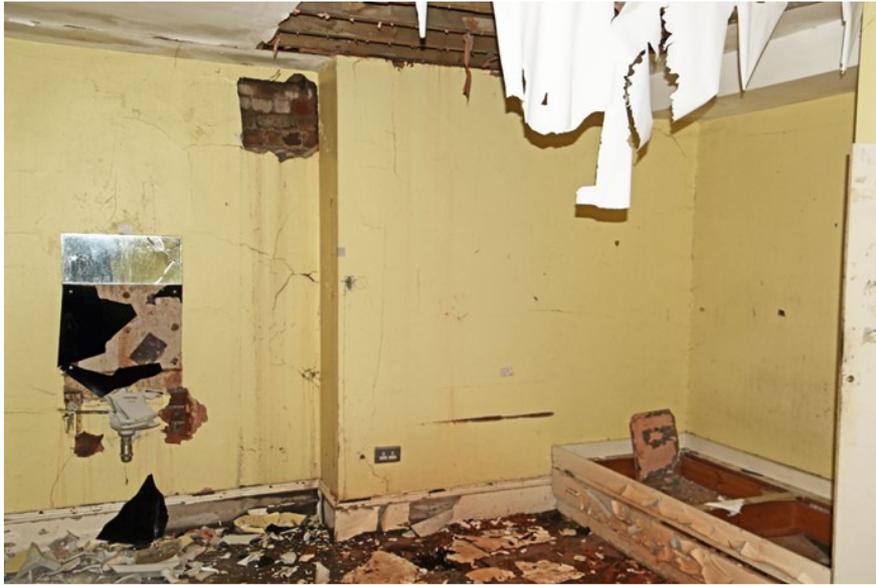
*Plate 36: Bedroom at rear of top floor*

The rear room at the south-eastern corner of the former house functioned as a double bedroom. The room is entered via a doorway with a four-panelled door set in a moulded-timber architrave. The room is lit by a window with a moulded-timber architrave, while the shutters are missing. There is no cornice in this room. There is a chimneybreast, though the hearth has been stopped up.

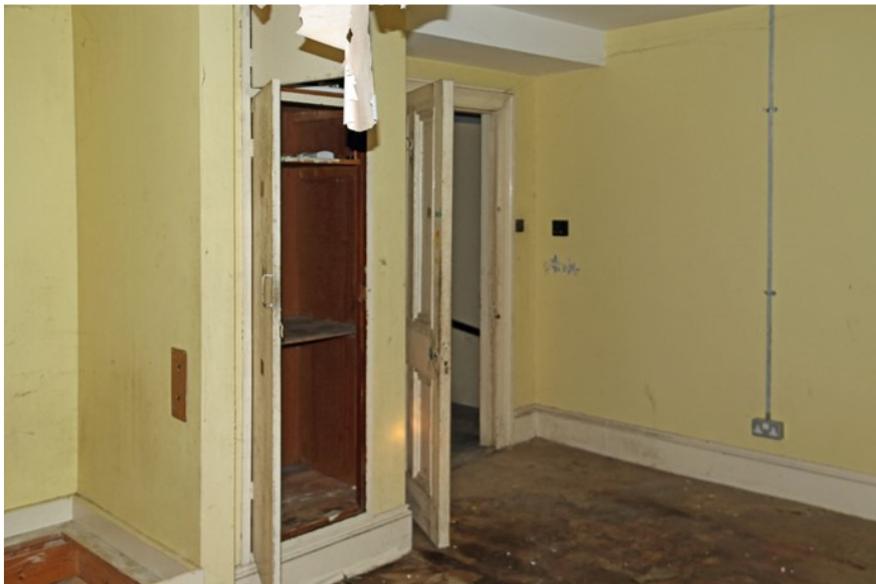
*Plate 37: Door to rear bedroom*

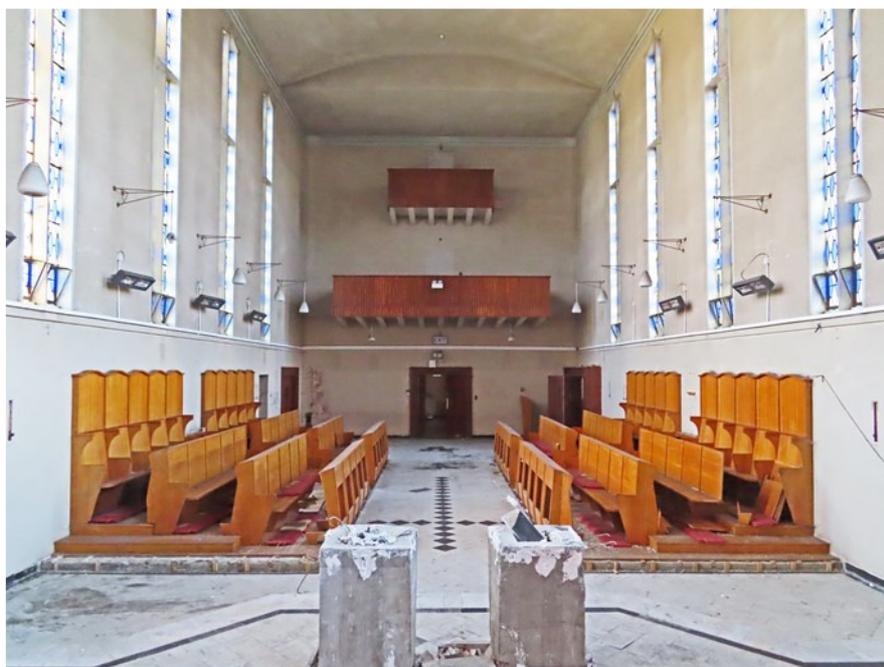
The chapel is the same height as the rest of the building, though internally it occupies the full height. It is lit at either side of the nave by five lancet windows with cruciform divisions and with a geometrical arrangement of coloured glass. The chancel is glazed on either side, with similar cruciform divisions. The exterior of the end wall of the chancel is faced with brick and has a dedication stone near the base. There are two galleries at the liturgical west end of the chapel, though the access to each is blocked off. The altar is missing. The pews and a confessional remain in place.

*Plate 39: Interior of chapel*

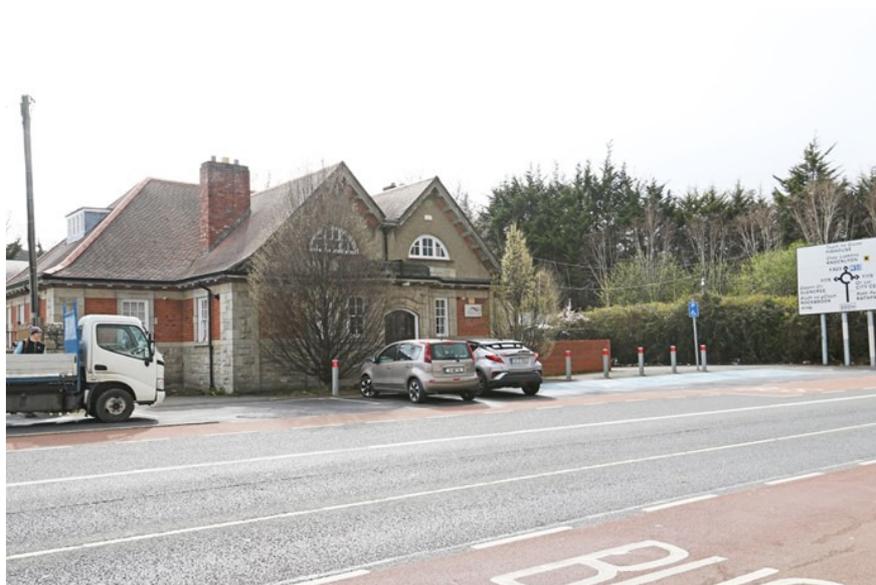
*Plate 42: Whitechurch Library, with application site beyond*

Whitechurch Library, located c. 40m to the east of the proposed development area, is a 1½ storey library building that was built in 1911 to the designs of T J Byrne, in the Arts and Crafts style. The ground-floor façade has a substantial breakfront in the centre, with two gables; this frontage is largely of rock-faced granite, with some red brick, particularly behind the breakfront. The gables are faced with roughcast render. The roof has a covering of small terracotta tiles, with red clay ridge and hip tiles. The eaves are bracketed and continue across the top of the ground-floor façade in the breakfront as a modillion cornice. The ground-floor windows are timber sliding sashes, while there are two Diocletian windows in the gables and there are dormers in the lesser elevations. The library is set back slightly from the road frontage.

It was noted above that Whitechurch Library is a protected structure and is included in the National Inventory of Architectural Heritage. The library building is c. 40m from the boundary of the application site. As is seen in plate 42, the application site has a dense belt of high trees on its eastern boundary. The proposal includes the retention of these trees and hence the present screening between Whitechurch Library and the proposed buildings will remain in place.
